# Access Compliance Report

## Public Rights-of-Way

### (Curb Ramps)

| Intersection ID: N/A | Main Street: COLONEL FRANCIS J BEATTY PARK DR | Cross Street: PARKGATE DR | Location: NW |

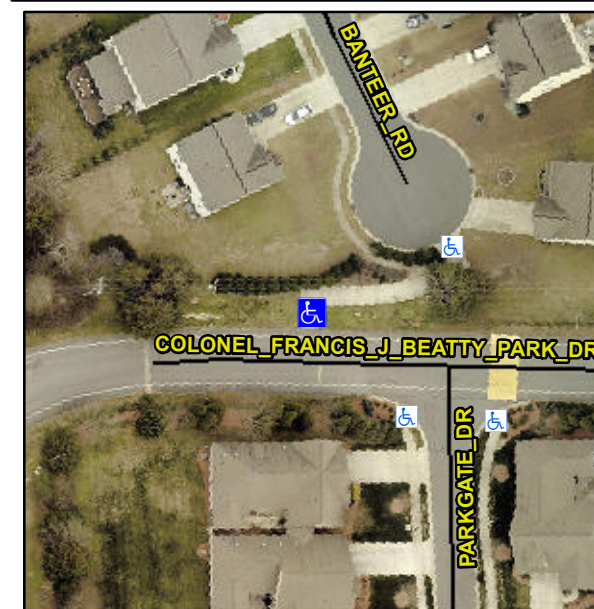
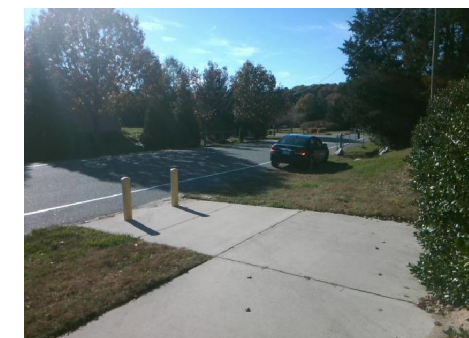
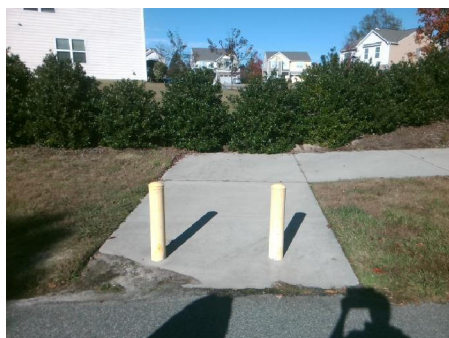
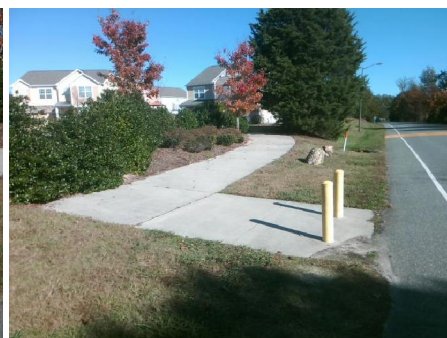
| ADA ID: 597B51320C9B | Ramp Type: Perp | Initial Pass/Fail: Pass | Overall Compliance: No |

| Severity Score: 15 | | | |

**Not Found, R304.2.2-Perp, R304.3.2-Para, R305, R304.5.4**

| Compliance | Description | Data | Compliance | Description | Data |
|---|---|---|---|---|---|
| Yes | Landing Length (in) | 115.0 | No | DWS Provided? | No |
| No | Landing Slope (%) | 3.4 | N/A | DWS Length (in) | N/A |
| Yes | Gutter Ponding? | No | No | Gutter Slope (%) | 7.2 |

**Remove & Replace Entire Ramp.  
Remove & Replace Gutter.**

Total Cost: \$ 2600.00
