Intersection ID: 10347	Main Street: KARENDALE_AV	Cross Street: ROGERS_ST	Location:	NE
ADA ID: 59870DC647C5	Ramp Type: Perp	Initial Pass/Fail: Fail	Overall Compliance: No	Severity Score: 12.5

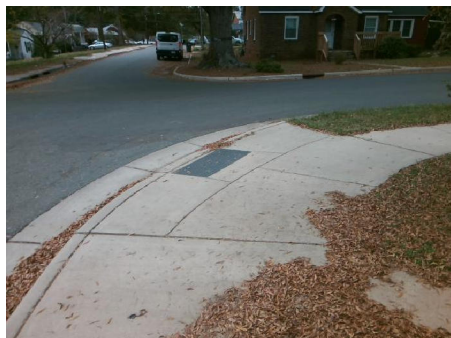
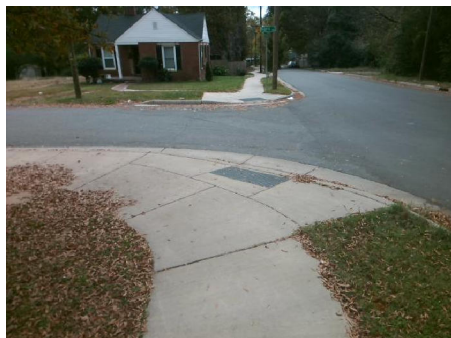
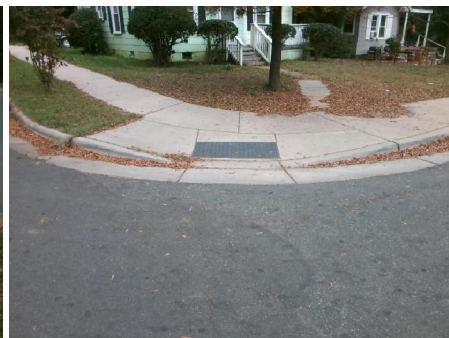
Compliance	Description	Data	Compliance	Description	Data
N/A	Ramp Length (in)	42.0	No	Ramp Slope (%)	8.6
Yes	Ramp Width (in)	48.0	Yes	Ramp XSlope (%)	1.7
N/A	Flare Type LT	N/A	N/A	Flare Type RT	N/A
N/A	Flare Slope LT (%)	N/A	N/A	Flare Slope RT (%)	N/A
N/A	Flare Traversable LT?	N/A	N/A	Flare Traversable RT?	N/A
N/A	Landing Length (in)	N/A	N/A	DWS Provided?	N/A
N/A	Landing Width (in)	N/A	N/A	DWS Contrast?	N/A
N/A	Landing Slope (%)	N/A	N/A	DWS Length (in)	N/A
N/A	Landing X Slope (%)	N/A	N/A	DWS Full Width?	N/A
N/A	Landing Curb? (Y/N)	N/A	N/A	DWS Offset (in)	N/A
N/A	Shared Landing?	N/A			
N/A	Gutter Ponding?	N/A	N/A	Gutter Slope (%)	N/A
N/A	Gutter Lip Ht (in)	N/A	N/A	Gutter X Slope (%)	N/A
N/A	Painted X Walk1?	No	N/A	Painted X Walk2?	N/A
	X Walk 1 Direction	To S		X Walk 2 Direction	N/A
N/A	X Walk 1 Width (in)	N/A	N/A	X Walk 2 Width (in)	N/A
	X Walk 1 Slope (%)	0.9		X Walk 2 Slope (%)	N/A
	X Walk 1 X Slope (%)	0.8		X Walk 2 X Slope (%)	N/A

N/A	Ramp inside XWalk1?	N/A	N/A	Ramp inside XWalk2?	N/A
	Road Slope (%)	N/A	N/A	Clear Space?	N/A
	Road X Slope (%)	N/A	N/A	Clear Space to XWalk (in)	N/A
N/A	Any Obstructions?	N/A	N/A	Storm Grate/Utility Hazard?	N/A
	Obstruction Type			Storm Grate/Utility Type	
		N/A			N/A
			Yes	Surface Condition? (G/P)	Good

Remove & Replace Entire Ramp.
