# Access Compliance Report

## Public Rights-of-Way

| Intersection ID: 10036601 | Main Street: RUSHMORE_DR | Cross Street: N/A | Location: NW |
| ADA ID: 598F4414161D | Ramp Type: PerpDiag | Initial Pass/Fail: Fail | Overall Compliance: No |

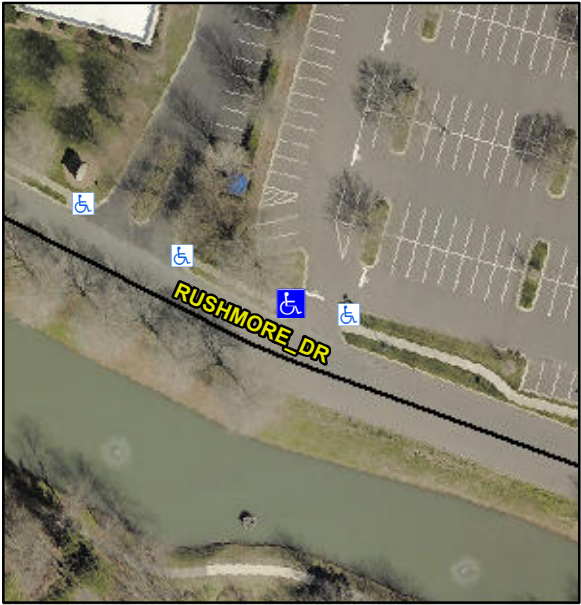
| | | No | Ramp Width (in) | 46.0 | No | Ramp XSlope (%) | 3.8 |
| <p>Surveyor Notes:</p> <p>N/A</p> <p>PROW/ADA:</p> <p>Not Found, R304.5.1, R304.5.3</p> | | | Road Slope (%) | 2.0 | N/A | Clear Space? | N/A |

| | Remove & Replace Curb Ramp With Two New Directional Ramps or Equivalent. | N/A | Ramp Length (in) | 95.0 | Yes | Ramp Slope (%) | 5.1 |
