Access Compliance Report

Public Rights-of-Way

(Curb Ramps)

Intersection ID: N/A	Main Street: BLYTHNE_BV	Cross Street: N/A	Location: NE
ADA ID: 59AEF6421D57	Ramp Type: Perp	Initial Pass/Fail: Fail	Overall Compliance: No
Severity Score: 22.5			
Codes/Mitigation Info/Possible Solution		Field Measurements/Component Compliance

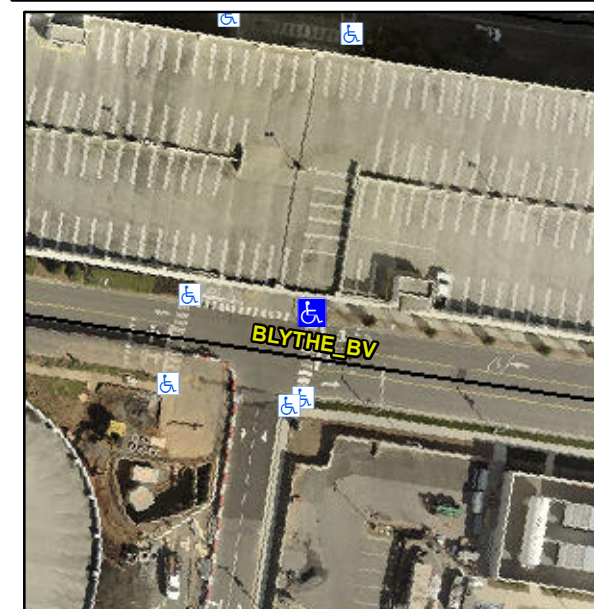
Not Found, R304.5.1, R304.2.2, R304.5.3

Compliance	Description	Data	Compliance	Description	Data
N/A	Ramp Length (in)	78.0	No	Ramp Slope (%)	8.9
No	Ramp Width (in)	47.5	No	Ramp XSlope (%)	4.1
N/A	Flare Type LT	N/A	N/A	Flare Type RT	N/A
N/A	Flare Slope LT (%)	N/A	N/A	Flare Slope RT (%)	N/A
N/A	Flare Traversable LT?	N/A	N/A	Flare Traversable RT?	N/A
N/A	Landing Length (in)	N/A	N/A	DWS Provided?	N/A
N/A	Landing Width (in)	N/A	N/A	DWS Contrast?	N/A
N/A	Landing Slope (%)	N/A	N/A	DWS Length (in)	N/A
N/A	Landing X Slope (%)	N/A	N/A	DWS Full Width?	N/A
N/A	Landing Curb? (Y/N)	N/A	N/A	DWS Offset (in)	N/A
N/A	Shared Landing?	N/A			
N/A	Gutter Ponding?	N/A	N/A	Gutter Slope (%)	N/A
N/A	Gutter Lip Ht (in)	N/A	N/A	Gutter X Slope (%)	N/A
N/A	Painted X Walk1?	Yes	N/A	Painted X Walk2?	N/A
	X Walk 1 Direction	To SW		X Walk 2 Direction	N/A
N/A	X Walk 1 Width (in)	74.0	N/A	X Walk 2 Width (in)	N/A
	X Walk 1 Slope (%)	11.5		X Walk 2 Slope (%)	N/A
	X Walk 1 X Slope (%)	2.0		X Walk 2 X Slope (%)	N/A

N/A	Ramp inside XWalk1?	Yes	N/A	Ramp inside XWalk2?	N/A
	Road Slope (%)	N/A	N/A	Clear Space?	N/A
	Road X Slope (%)	N/A	N/A	Clear Space to XWalk (in)	N/A
N/A	Any Obstructions?	N/A	N/A	Storm Grate/Utility Hazard?	N/A
	Obstruction Type			Storm Grate/Utility Type	
		N/A			N/A
			Yes	Surface Condition? (G/P)	Good

Possible Solutions:

Remove & Replace Entire Ramp.
