Access Compliance Report

Public Rights-of-Way

(Curb Ramps)

Intersection ID: N/A	Main Street: GRAHAM_ST	Cross Street: N/A	Location: NW
ADA ID: 59AF16FB3227	Ramp Type: Directional1	Initial Pass/Fail: Fail	Overall Compliance: No
Severity Score: 1.25			
Codes/Mitigation Info/Possible Solution		Field Measurements/Component Compliance

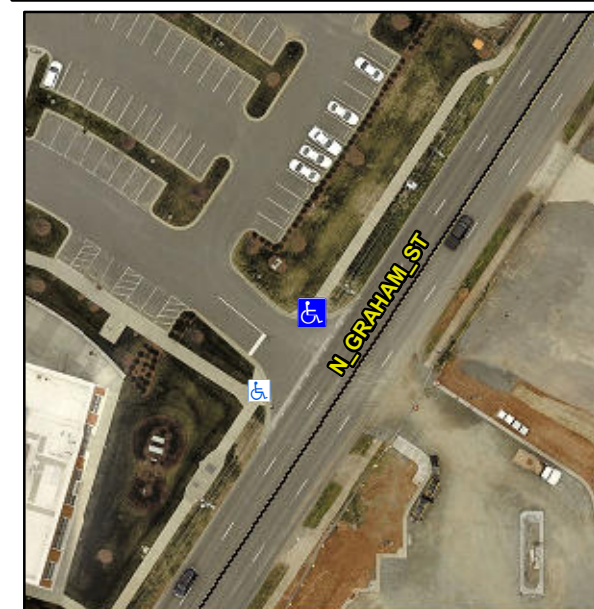
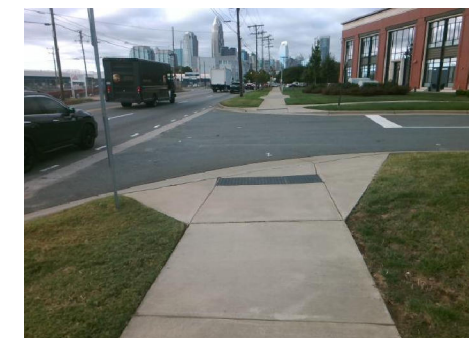
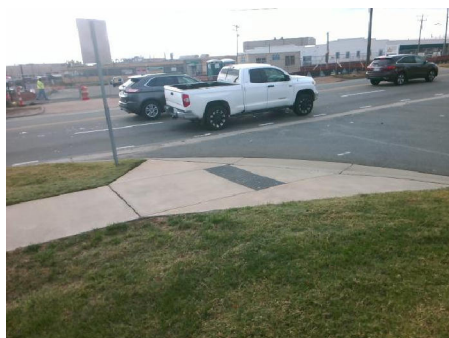
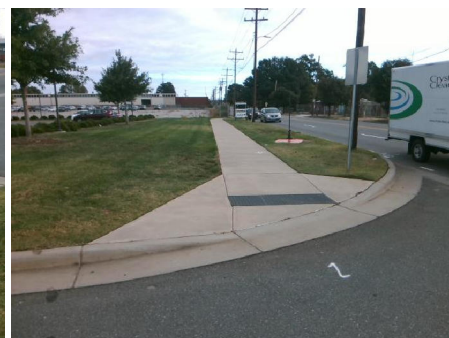
R304.5.3

Compliance	Description	Data	Compliance	Description	Data
N/A	Ramp Length (in)	96.0	N/A	Grade Break?	N/A
Yes	Ramp Width (in)	72.0	N/A	Grade Break Slope (%)	0.0
Yes	Ramp Slope (%)	3.4	N/A	Grade Break XSlope (%)	0.0
No	Ramp XSlope (%)	4.7			
N/A	Flare Type LT	N/A	N/A	Flare Type RT	N/A
N/A	Flare Slope LT (%)	N/A	N/A	Flare Slope RT (%)	0.0
N/A	Flare Traversable LT?	N/A	N/A	Flare Traversable RT?	N/A
N/A	Landing Length (in)	0.0	N/A	DWS Provided?	N/A
N/A	Landing Width (in)	0.0	N/A	DWS Contrast?	N/A
N/A	Landing Slope (%)	0.0	N/A	DWS Length (in)	N/A
N/A	Landing X Slope (%)	0.0	N/A	DWS Full Width?	N/A
N/A	Landing Curb? (Y/N)	N/A	N/A	DWS Offset LT (in)	N/A
N/A	Shared Landing?	N/A	N/A	DWS Offset RT (in)	N/A
N/A	Gutter Ponding?	0.0	N/A	Gutter Slope (%)	N/A
N/A	Gutter Lip Ht (in)	0.0	N/A	Gutter X Slope (%)	N/A
N/A	Painted X Walk1?	No		Road Slope (%)	2.0
	X Walk 1 Direction	To S		Road X Slope (%)	2.4
	X Walk 1 Width (in)	N/A		Clear Space?	N/A

X Walk 1 Slope (%)	2.0	N/A	Clear Space to XWalk (in)	N/A
	X Walk 1 X Slope (%)	2.4	N/A	Storm Grate/Utility Hazard?	N/A
N/A	Ramp inside XWalk1?	N/A		Storm Grate/Utility Type	
N/A	Any Obstructions?	N/A			N/A
	Obstruction Type		Yes	Surface Condition? (G/P)	Good
			N/A	Curb Slope (%)	7.6

Remove & Replace Entire Ramp.

\$ 1600.00
