Access Compliance Report

Public Rights-of-Way

(Curb Ramps)

Intersection ID: 12779	Main Street: E_TRADE_ST	Cross Street: S_DAVIDSON_ST	Location: E
ADA ID: 59B124A0E386	Ramp Type: PerpDiag	Initial Pass/Fail: Fail	Overall Compliance: No
		Severity Score: 12.5

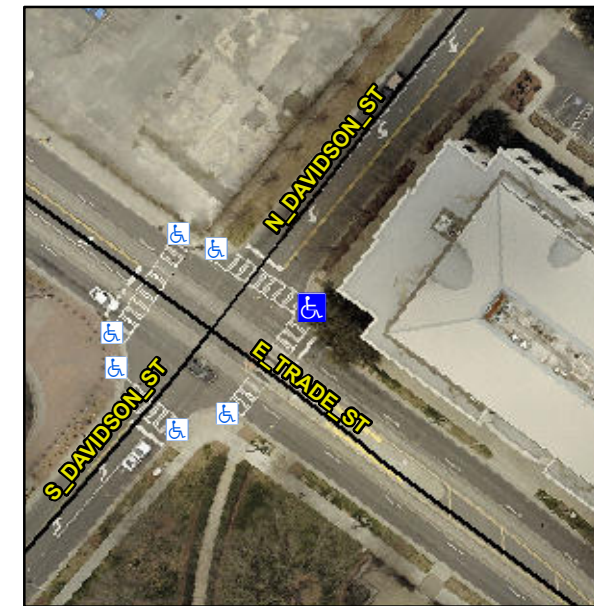
Not Found, R304.5.3

Compliance	Description	Data	Compliance	Description	Data
N/A	Ramp Length (in)	46.0	Yes	Ramp Slope (%)	7.9
Yes	Ramp Width (in)	48.0	No	Ramp XSlope (%)	5.1
N/A	Flare Type LT	N/A	N/A	Flare Type RT	N/A
N/A	Flare Slope LT (%)	N/A	N/A	Flare Slope RT (%)	N/A
N/A	Flare Traversable LT?	N/A	N/A	Flare Traversable RT?	N/A
N/A	Landing Length (in)	N/A	N/A	DWS Provided?	N/A
N/A	Landing Width (in)	N/A	N/A	DWS Contrast?	N/A
N/A	Landing Slope (%)	N/A	N/A	DWS Length (in)	N/A
N/A	Landing X Slope (%)	N/A	N/A	DWS Full Width?	N/A
N/A	Landing Curb? (Y/N)	N/A	N/A	DWS Offset (in)	N/A
N/A	Shared Landing?	N/A			
N/A	Gutter Ponding?	N/A	N/A	Gutter Slope (%)	N/A
N/A	Gutter Lip Ht (in)	N/A	N/A	Gutter X Slope (%)	N/A
N/A	Painted X Walk1?	Yes	N/A	Painted X Walk2?	Yes
	X Walk 1 Direction	To NW		X Walk 2 Direction	To SW
N/A	X Walk 1 Width (in)	113.0	N/A	X Walk 2 Width (in)	112.0
	X Walk 1 Slope (%)	2.5		X Walk 2 Slope (%)	1.7
	X Walk 1 X Slope (%)	2.2		X Walk 2 X Slope (%)	1.6

N/A	Ramp inside XWalk1?	Yes	N/A	Ramp inside XWalk2?	Yes
	Road Slope (%)	2.4	N/A	Clear Space?	N/A
	Road X Slope (%)	0.8	N/A	Clear Space to XWalk (in)	N/A
N/A	Any Obstructions?	N/A	N/A	Storm Grate/Utility Hazard?	N/A
	Obstruction Type			Storm Grate/Utility Type	
		N/A			N/A
		Yes		Surface Condition? (G/P)	Good

Remove & Replace Curb Ramp With Two New Directional Ramps or Equivalent.

Total Cost: \$ 3200.00
