Access Compliance Report

Public Rights-of-Way

(Curb Ramps)

Intersection ID: 43757	Main Street: DERVISH_LN	Cross Street: ZIEGLER_LN	Location:	W
ADA ID: 59B217C819BA	Ramp Type: PerpDiag	Initial Pass/Fail: Fail	Overall Compliance: No	Severity Score: 17.5
Codes/Mitigation Info/Possible Solution		Field Measurements/Component Compliance

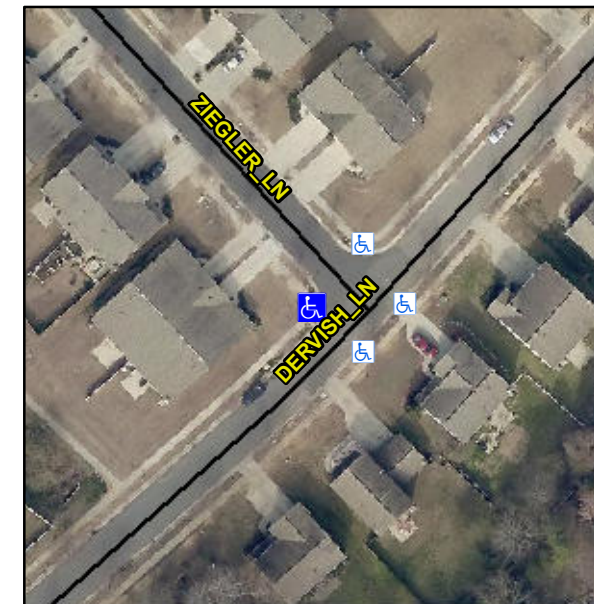
Not Found, R304.5.1

Compliance	Description	Data	Compliance	Description	Data
N/A	Ramp Length (in)	49.0	Yes	Ramp Slope (%)	6.4
No	Ramp Width (in)	35.0	Yes	Ramp XSlope (%)	1.6
N/A	Flare Type LT	N/A	N/A	Flare Type RT	N/A
N/A	Flare Slope LT (%)	N/A	N/A	Flare Slope RT (%)	N/A
N/A	Flare Traversable LT?	N/A	N/A	Flare Traversable RT?	N/A
N/A	Landing Length (in)	N/A	N/A	DWS Provided?	N/A
N/A	Landing Width (in)	N/A	N/A	DWS Contrast?	N/A
N/A	Landing Slope (%)	N/A	N/A	DWS Length (in)	N/A
N/A	Landing X Slope (%)	N/A	N/A	DWS Full Width?	N/A
N/A	Landing Curb? (Y/N)	N/A	N/A	DWS Offset (in)	N/A
N/A	Shared Landing?	N/A			
N/A	Gutter Ponding?	N/A	N/A	Gutter Slope (%)	N/A
N/A	Gutter Lip Ht (in)	N/A	N/A	Gutter X Slope (%)	N/A
N/A	Painted X Walk1?	No	N/A	Painted X Walk2?	No
	X Walk 1 Direction	To SE		X Walk 2 Direction	To NE
N/A	X Walk 1 Width (in)	N/A	N/A	X Walk 2 Width (in)	N/A
	X Walk 1 Slope (%)	6.6		X Walk 2 Slope (%)	8.0
	X Walk 1 X Slope (%)	4.7		X Walk 2 X Slope (%)	2.9

N/A	Ramp inside XWalk1?	N/A	N/A	Ramp inside XWalk2?	N/A
	Road Slope (%)	2.4	N/A	Clear Space?	N/A
	Road X Slope (%)	7.4	N/A	Clear Space to XWalk (in)	N/A
N/A	Any Obstructions?	N/A	N/A	Storm Grate/Utility Hazard?	N/A
	Obstruction Type			Storm Grate/Utility Type	
		N/A			N/A
			Yes	Surface Condition? (G/P)	Good

Remove & Replace Curb Ramp With Two New Directional Ramps or Equivalent.
