Access Compliance Report

Public Rights-of-Way

(Curb Ramps)

Intersection ID: 27505	Main Street: WATERSREACH_LN	Cross Street: WOODRIVER_LN	Location: S
ADA ID: 59BA4B0B9A92	Ramp Type: PerpDiag	Initial Pass/Fail: Fail	Overall Compliance: No
		Severity Score: 22.5

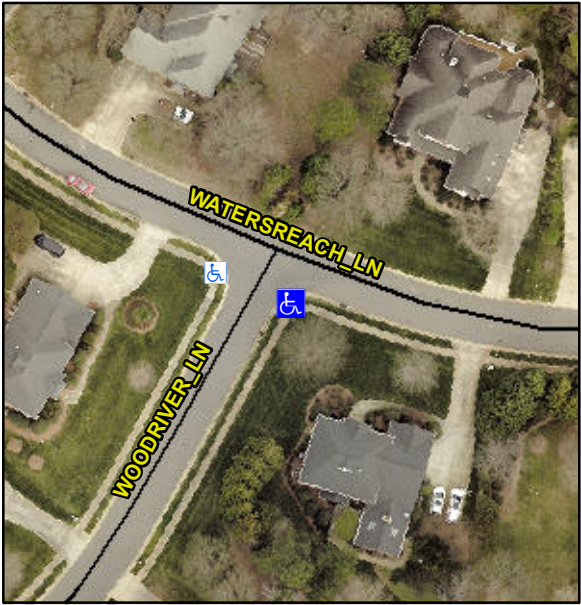
<p>Possible Solutions:</p> <p>Remove & Replace Curb Ramp With Two New Directional Ramps or Equivalent.</p>	<p>Compliance</p> <p>Description</p> <p>Data</p>	<p>Compliance</p> <p>Description</p> <p>Data</p>		
	<p>Surveyor Notes:</p> <p>N/A</p> <p>PROW/ADA:</p> <p>Not Found, R304.5.1, R304.2.2, R304.5.3</p>	<p>N/A</p> <p>Ramp Length (in)</p> <p>95.0</p> <p>No</p> <p>Ramp Width (in)</p> <p>45.0</p> <p>N/A</p> <p>Flare Type LT</p> <p>N/A</p> <p>Flare Slope LT (%)</p> <p>N/A</p> <p>Flare Traversable LT?</p> <p>N/A</p> <p>Landing Length (in)</p> <p>N/A</p> <p>Landing Width (in)</p> <p>N/A</p> <p>Landing Slope (%)</p> <p>N/A</p> <p>Landing X Slope (%)</p> <p>N/A</p> <p>Landing Curb? (Y/N)</p> <p>N/A</p> <p>Shared Landing?</p> <p>N/A</p> <p>Gutter Ponding?</p> <p>N/A</p> <p>Gutter Lip Ht (in)</p> <p>N/A</p> <p>Painted X Walk1?</p> <p>No</p> <p>X Walk 1 Direction</p> <p>To NE</p> <p>N/A</p> <p>X Walk 1 Width (in)</p> <p>N/A</p> <p>X Walk 1 Slope (%)</p> <p>1.3</p> <p>X Walk 1 X Slope (%)</p> <p>1.4</p> <p>N/A</p> <p>Ramp inside XWalk1?</p> <p>N/A</p> <p>Road Slope (%)</p> <p>3.9</p> <p>Road X Slope (%)</p> <p>4.1</p> <p>N/A</p> <p>Any Obstructions?</p> <p>N/A</p> <p>Obstruction Type</p> <p>N/A</p>	<p>No</p> <p>Ramp Slope (%)</p> <p>9.3</p> <p>No</p> <p>Ramp XSlope (%)</p> <p>4.1</p> <p>N/A</p> <p>Flare Type RT</p> <p>N/A</p> <p>Flare Slope RT (%)</p> <p>N/A</p> <p>Flare Traversable RT?</p> <p>N/A</p> <p>DWS Provided?</p> <p>N/A</p> <p>DWS Contrast?</p> <p>N/A</p> <p>DWS Length (in)</p> <p>N/A</p> <p>DWS Full Width?</p> <p>N/A</p> <p>DWS Offset (in)</p> <p>N/A</p> <p>N/A</p> <p>Gutter Slope (%)</p> <p>N/A</p> <p>Gutter X Slope (%)</p> <p>N/A</p> <p>Painted X Walk2?</p> <p>No</p> <p>X Walk 2 Direction</p> <p>To NW</p> <p>N/A</p> <p>X Walk 2 Width (in)</p> <p>N/A</p> <p>X Walk 2 Slope (%)</p> <p>0.6</p> <p>X Walk 2 X Slope (%)</p> <p>3.6</p> <p>N/A</p> <p>Ramp inside XWalk2?</p> <p>N/A</p> <p>Clear Space?</p> <p>N/A</p> <p>Clear Space to XWalk (in)</p> <p>N/A</p> <p>Storm Grate/Utility Hazard?</p> <p>N/A</p> <p>Storm Grate/Utility Type</p> <p>N/A</p> <p>N/A</p> <p>Surface Condition? (G/P)</p> <p>Good</p>
