Access Compliance Report

Public Rights-of-Way

(Curb Ramps)

Intersection ID: 27847	Main Street: PARADISE_RIDGE_RD	Cross Street: NORTH_COMMUNITY_HOUSE_RD	Location: SW
ADA ID: 59BD2F2FAC6D	Ramp Type: Perp	Initial Pass/Fail: Fail	Overall Compliance: No
Severity Score: 12.5			
Codes/Mitigation Info/Possible Solution		Field Measurements/Component Compliance

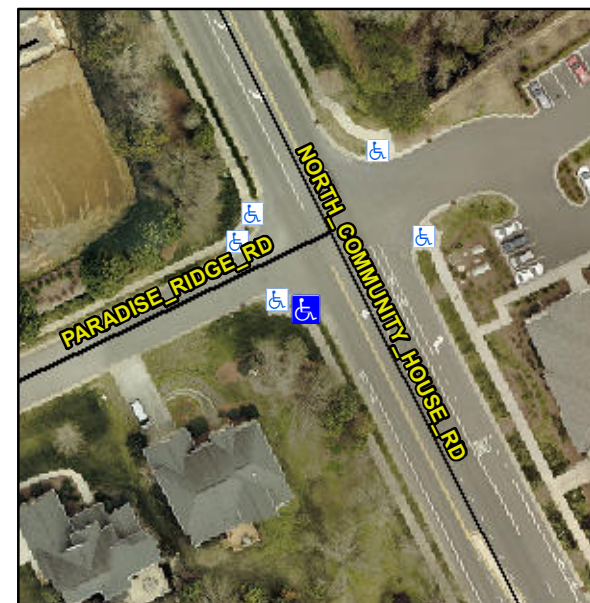
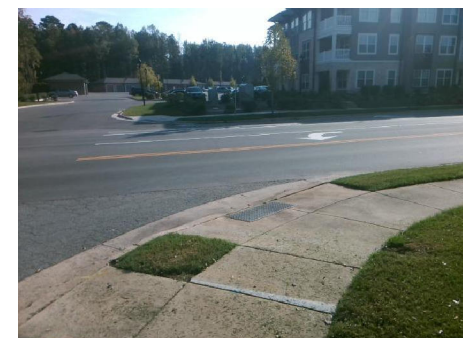
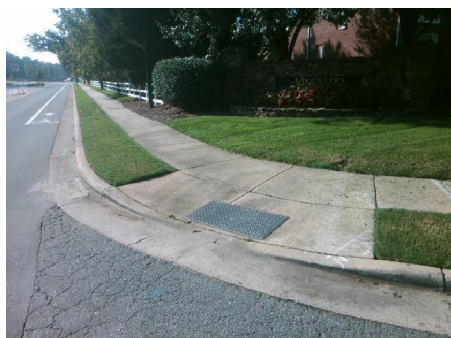
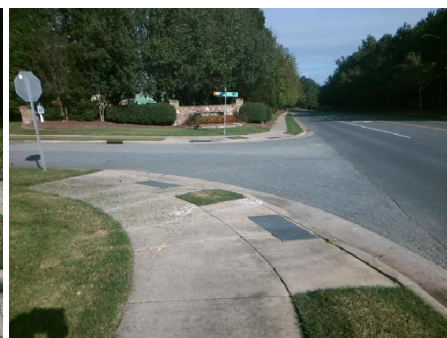
Compliance	Description	Data	Compliance	Description	Data
N/A	Ramp Length (in)	47.0	No	Ramp Slope (%)	11.8
Yes	Ramp Width (in)	48.0	Yes	Ramp XSlope (%)	1.3
N/A	Flare Type LT	N/A	N/A	Flare Type RT	N/A
N/A	Flare Slope LT (%)	N/A	N/A	Flare Slope RT (%)	N/A
N/A	Flare Traversable LT?	N/A	N/A	Flare Traversable RT?	N/A
N/A	Landing Length (in)	N/A	N/A	DWS Provided?	N/A
N/A	Landing Width (in)	N/A	N/A	DWS Contrast?	N/A
N/A	Landing Slope (%)	N/A	N/A	DWS Length (in)	N/A
N/A	Landing X Slope (%)	N/A	N/A	DWS Full Width?	N/A
N/A	Landing Curb? (Y/N)	N/A	N/A	DWS Offset (in)	N/A
N/A	Shared Landing?	N/A			
N/A	Gutter Ponding?	N/A	N/A	Gutter Slope (%)	N/A
N/A	Gutter Lip Ht (in)	N/A	N/A	Gutter X Slope (%)	N/A
N/A	Painted X Walk1?	No	N/A	Painted X Walk2?	N/A
	X Walk 1 Direction	To NE		X Walk 2 Direction	N/A
N/A	X Walk 1 Width (in)	N/A	N/A	X Walk 2 Width (in)	N/A
	X Walk 1 Slope (%)	1.4		X Walk 2 Slope (%)	N/A
	X Walk 1 X Slope (%)	0.7		X Walk 2 X Slope (%)	N/A

N/A	Ramp inside XWalk1?	N/A	N/A	Ramp inside XWalk2?	N/A
	Road Slope (%)	N/A	N/A	Clear Space?	N/A
	Road X Slope (%)	N/A	N/A	Clear Space to XWalk (in)	N/A
N/A	Any Obstructions?	N/A	N/A	Storm Grate/Utility Hazard?	N/A
	Obstruction Type			Storm Grate/Utility Type	
		N/A			N/A
			Yes	Surface Condition? (G/P)	Good

Possible Solutions:

Remove & Replace Entire Ramp.
