Access Compliance Report

Public Rights-of-Way

(Curb Ramps)

| Intersection ID: 14720 | Main Street: E_5TH_ST | Cross Street: N_DOTGER_AV | Location: S |

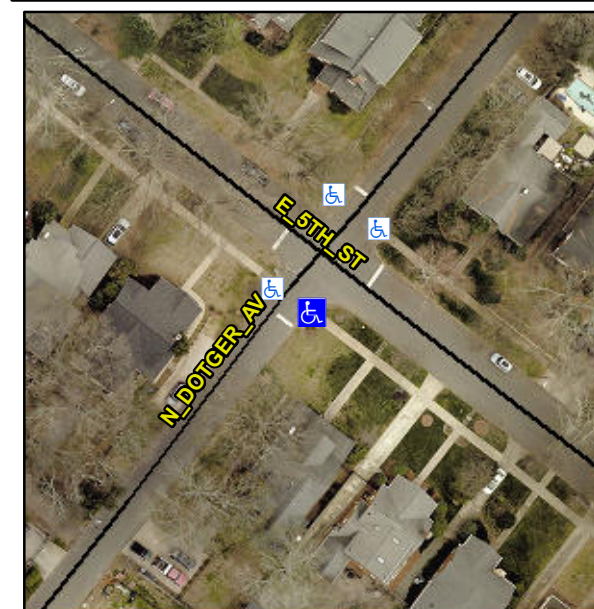
| ADA ID: 59C611CEE254 | Ramp Type: Directional1 | Initial Pass/Fail: Fail | Overall Compliance: No |

R304.5.3

| Compliance | Description | Data | Compliance | Description | Data |
|---|---|---|---|---|---|
| No | Ramp XSlope (%) | 3.8 | | | |

Remove & Replace Entire Ramp.

\$ 1600.00
