## Access Compliance Report Public Rights-of-Way (Curb Ramps)

Intersection ID: 27824 Main Street: BALLANTYNE\_CROSSING\_AV Cross Street: TRADING\_PATH\_WY Location: SE

ADA ID: 59D84B010FAD Ramp Type: Perp Initial Pass/Fail: Fail Overall Compliance: No Severity Score: 25

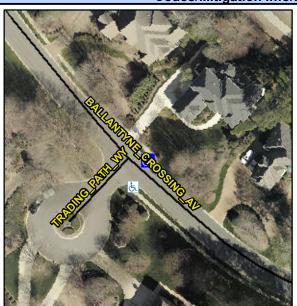
Compliance Description Data Compliance Description Data No N/A Ramp Length (in) 48.0 Ramp Slope (%) 13.1 Yes Ramp XSlope (%) Yes Ramp Width (in) 48.0 0.0 N/A N/A Flare Type LT N/A Flare Type RT N/A N/A N/A N/A Flare Slope RT (%) N/A Flare Slope LT (%) N/A Flare Traversable LT? N/A N/A Flare Traversable RT? N/A N/A N/A N/A DWS Provided? N/A Landing Length (in) N/A Landing Width (in) N/A N/A **DWS Contrast?** N/A N/A N/A N/A Landing Slope (%) DWS Length (in) N/A N/A Landing X Slope (%) N/A N/A DWS Full Width? N/A N/A Landing Curb? (Y/N) N/A N/A DWS Offset (in) N/A N/A N/A Shared Landing? N/A **Gutter Ponding?** N/A N/A Gutter Slope (%) N/A N/A Gutter Lip Ht (in) N/A N/A Gutter X Slope (%) N/A N/A Painted X Walk1? No N/A Painted X Walk2? N/A X Walk 1 Direction To SW X Walk 2 Direction N/A N/A N/A N/A X Walk 1 Width (in) X Walk 2 Width (in) N/A X Walk 1 Slope (%) 3.3 X Walk 2 Slope (%) N/A X Walk 1 X Slope (%) 2.9 X Walk 2 X Slope (%) N/A N/A N/A N/A Ramp inside XWalk2? Ramp inside XWalk1? N/A Road Slope (%) N/A N/A Clear Space? N/A N/A Road X Slope (%) N/A Clear Space to XWalk (in) N/A N/A N/A Any Obstructions? N/A Storm Grate/Utility Hazard? N/A **Obstruction Type** Storm Grate/Utility Type N/A N/A

Remove & Replace Entire Ramp.
