# Access Compliance Report

## Public Rights-of-Way

### (Curb Ramps)

| Intersection ID: 44173 | Main Street: BELLEGARDE_DR | Cross Street: BOBHOUSE_DR | Location: SE |

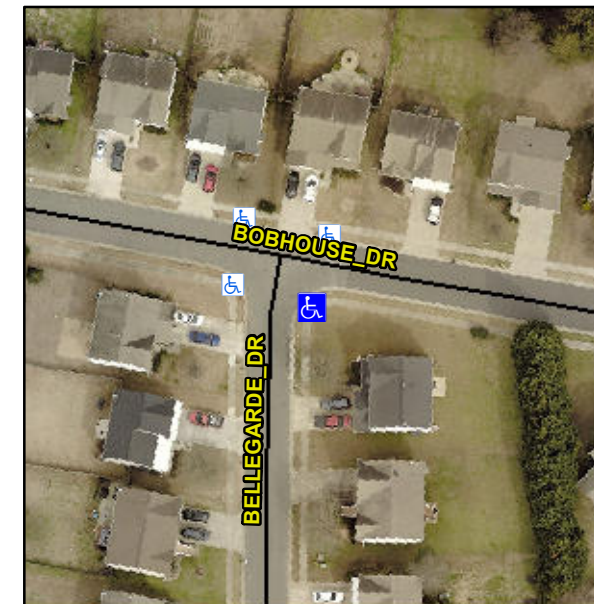
| ADA ID: 59E0F546ECAB | Ramp Type: PerpDiag | Initial Pass/Fail: Fail | Overall Compliance: No |
| Severity Score: 21.25 | | | |

**R304.5.1, R304.2.2**

| Compliance | Description | Data | Compliance | Description | Data |
|---|---|---|---|---|---|
| N/A | Ramp Length (in) | 49.0 | No | Ramp Slope (%) | 10.5 |
| No | Ramp Width (in) | 38.0 | Yes | Ramp XSlope (%) | 1.8 |

**Remove & Replace Curb Ramp With Two New Directional Ramps or Equivalent.**

Total Cost: \$ 3200.00

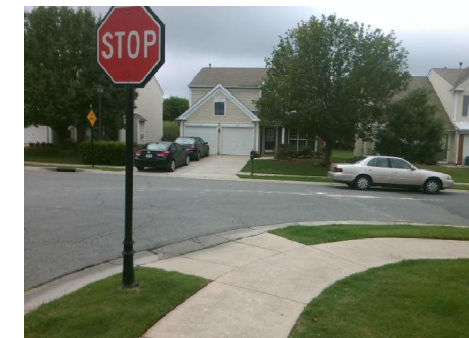
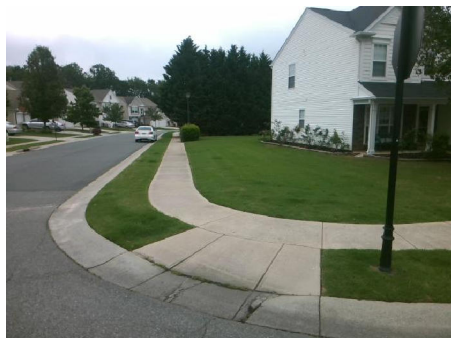
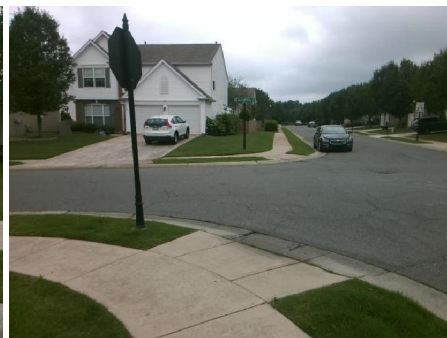
| Compliance | Description | Data | Compliance | Description | Data |
|---|---|---|---|---|---|
| | | | Yes | Surface Condition? (G/P) | Good |
