# Access Compliance Report

## Public Rights-of-Way

### (Curb Ramps)

Intersection ID: 11017	Main Street: DRUMMOND_AV	Cross Street: PARSON_ST	Location: W
ADA ID: 59E8E946C0BD	Ramp Type: Perp	Initial Pass/Fail: Fail	Overall Compliance: No
Severity Score: 13.75			
Codes/Mitigation Info/Possible Solution		Field Measurements/Component Compliance

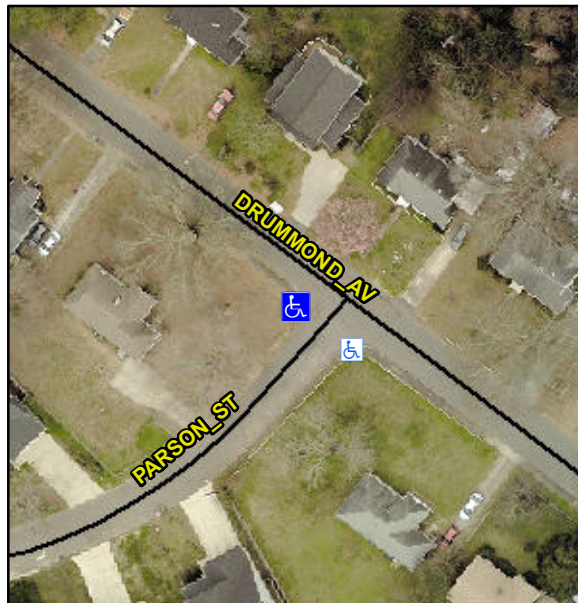
**Not Found, R304.2.2, R304.5.3**

Compliance	Description	Data	Compliance	Description	Data
N/A	Ramp Length (in)	38.5	No	Ramp Slope (%)	11.8
Yes	Ramp Width (in)	48.0	No	Ramp XSlope (%)	4.9
N/A	Flare Type LT	N/A	N/A	Flare Type RT	N/A
N/A	Flare Slope LT (%)	N/A	N/A	Flare Slope RT (%)	N/A
N/A	Flare Traversable LT?	N/A	N/A	Flare Traversable RT?	N/A
N/A	Landing Length (in)	N/A	N/A	DWS Provided?	N/A
N/A	Landing Width (in)	N/A	N/A	DWS Contrast?	N/A
N/A	Landing Slope (%)	N/A	N/A	DWS Length (in)	N/A
N/A	Landing X Slope (%)	N/A	N/A	DWS Full Width?	N/A
N/A	Landing Curb? (Y/N)	N/A	N/A	DWS Offset (in)	N/A
N/A	Shared Landing?	N/A			
N/A	Gutter Ponding?	N/A	N/A	Gutter Slope (%)	N/A
N/A	Gutter Lip Ht (in)	N/A	N/A	Gutter X Slope (%)	N/A
N/A	Painted X Walk1?	No	N/A	Painted X Walk2?	N/A
	X Walk 1 Direction	To SE		X Walk 2 Direction	N/A
N/A	X Walk 1 Width (in)	N/A	N/A	X Walk 2 Width (in)	N/A
	X Walk 1 Slope (%)	4.9		X Walk 2 Slope (%)	N/A
	X Walk 1 X Slope (%)	3.6		X Walk 2 X Slope (%)	N/A

N/A	Ramp inside XWalk1?	N/A	N/A	Ramp inside XWalk2?	N/A
	Road Slope (%)	N/A	N/A	Clear Space?	N/A
	Road X Slope (%)	N/A	N/A	Clear Space to XWalk (in)	N/A
N/A	Any Obstructions?	N/A	N/A	Storm Grate/Utility Hazard?	N/A
	Obstruction Type			Storm Grate/Utility Type	
		N/A			N/A
			Yes	Surface Condition? (G/P)	Good

**Remove & Replace Entire Ramp.**
