## Access Compliance Report Public Rights-of-Way (Curb Ramps)

Intersection ID: 6720Main Street:DEBERRY\_CTCross Street:ROUNDLEAF\_DRLocation:SADA ID: 59ED47712518Ramp Type:PerpInitial Pass/Fail:FailOverall Compliance:NoSeverity Score:10

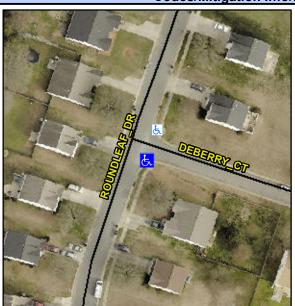
| Field Measurements/Component Compliance | | | | | | |
|---|---|---|---|---|---|---|
| N | lo | Ramp Width (in) | 36.5 | No | Ramp XSlope (%) | 2.9 |

Total Cost: \$ 1850.00
