Access Compliance Report

Public Rights-of-Way

(Curb Ramps)

Intersection ID: N/A	Main Street: BEREWICK_TOWN_CENTRE	Cross Street: N/A	Location: NW
ADA ID: 59F058CA1BDA	Ramp Type: Perp	Initial Pass/Fail: Pass	Overall Compliance: No
Severity Score: 0			
Codes/Mitigation Info/Possible Solution		Field Measurements/Component Compliance

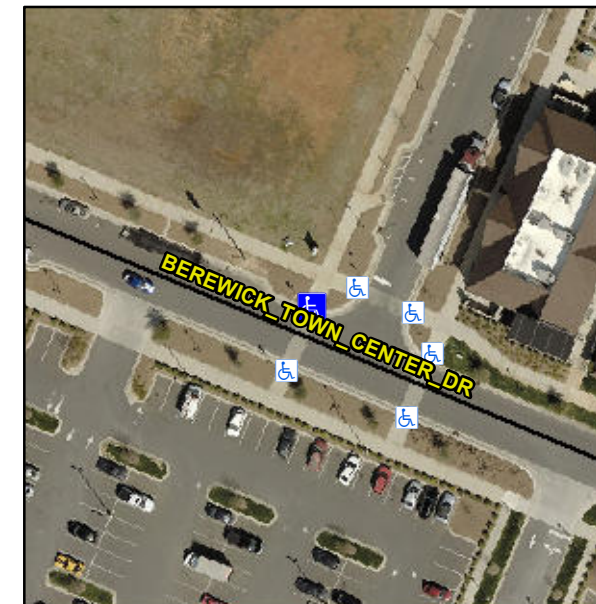
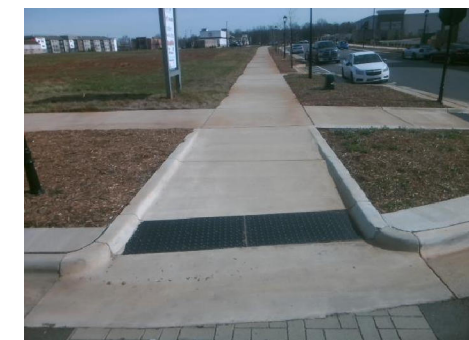
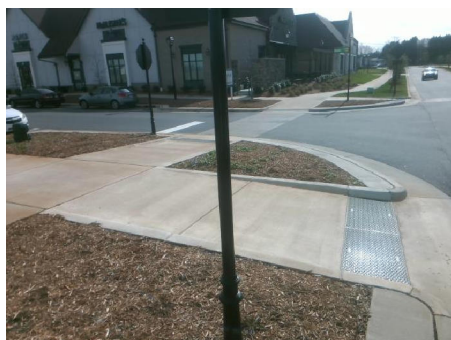
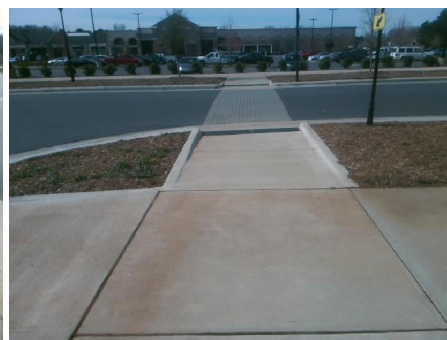
Not Found, R305.2

Compliance	Description	Data	Compliance	Description	Data
N/A	Ramp Length (in)	176.0	Yes	Ramp Slope (%)	6.6
Yes	Ramp Width (in)	89.0	Yes	Ramp XSlope (%)	1.0
Yes	Flare Type L	Curbed_NoWalkSurface	Yes	Flare Type RT	N/A
Yes	Flare Slope LT (%)	N/A	N/A	Flare Slope RT (%)	N/A
N/A	Flare Traversable LT?	No	N/A	Flare Traversable RT?	No
Yes	Landing Length (in)	95.0	Yes	DWS Provided?	Yes
Yes	Landing Width (in)	89.0	Yes	DWS Contrast?	Yes
Yes	Landing Slope (%)	0.5	Yes	DWS Length (in)	24.0
Yes	Landing X Slope (%)	1.4	Yes	DWS Full Width?	Yes
N/A	Landing Curb? (Y/N)	No	No	DWS Offset (in)	4.5
N/A	Shared Landing?	Yes			
Yes	Gutter Ponding?	No	Yes	Gutter Slope (%)	1.4
Yes	Gutter Lip Ht (in)	0.0	Yes	Gutter X Slope (%)	1.9
N/A	Painted X Walk1?	Yes	N/A	Painted X Walk2?	N/A
	X Walk 1 Direction	To SW		X Walk 2 Direction	N/A
N/A	X Walk 1 Width (in)	97.5	N/A	X Walk 2 Width (in)	N/A
	X Walk 1 Slope (%)	1.3		X Walk 2 Slope (%)	N/A
	X Walk 1 X Slope (%)	2.0		X Walk 2 X Slope (%)	N/A

Yes	Ramp inside XWalk1?	Yes	N/A	Ramp inside XWalk2?	N/A
	Road Slope (%)	N/A	N/A	Clear Space?	Yes
	Road X Slope (%)	N/A	N/A	Clear Space to XWalk (in)	N/A
Yes	Any Obstructions?	No	Yes	Storm Grate/Utility Hazard?	No
	Obstruction Type			Storm Grate/Utility Type	
		N/A			N/A
			Yes	Surface Condition? (G/P)	Good

Remove & Replace Entire Ramp.

Total Cost: \$ 1850.00
