Access Compliance Report

Public Rights-of-Way

(Curb Ramps)

Intersection ID: 6185	Main Street: STATESVILLE_RD	Cross Street: ORR_ST	Location: SE
ADA ID: 59F14DE9A9CB	Ramp Type: Directional1	Initial Pass/Fail: Pass	Overall Compliance: No
Severity Score: 0			
Codes/Mitigation Info/Possible Solution		Field Measurements/Component Compliance

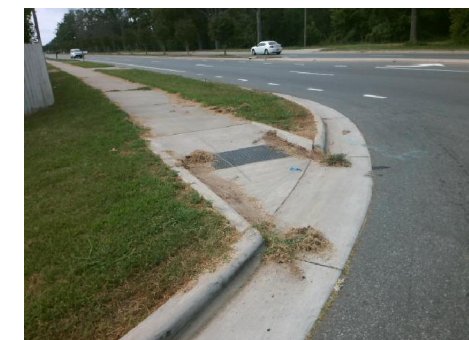
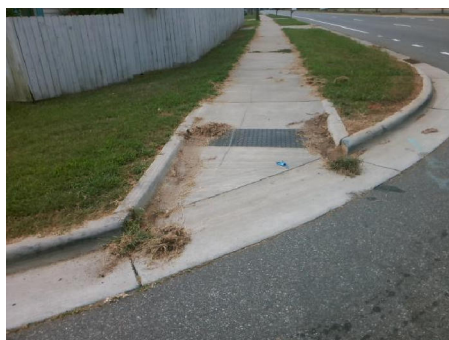
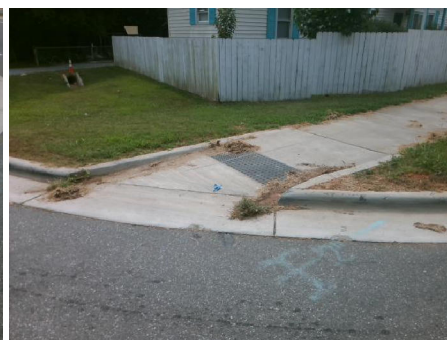
VEGETATION OVERGROWTH

Compliance	Description	Data	Compliance	Description	Data
N/A	Ramp Length (in)	74.0	Yes	Grade Break?	Yes
Yes	Ramp Width (in)	71.5	No	Grade Break Slope (%)	6.1
Yes	Ramp Slope (%)	6.6	Yes	Grade Break XSlope (%)	1.9
Yes	Ramp XSlope (%)	0.9			
Yes	Flare Type LT	N/A	Yes	Flare Type RT	N/A
N/A	Flare Slope LT (%)	N/A	N/A	Flare Slope RT (%)	N/A
N/A	Flare Traversable LT?	No	N/A	Flare Traversable RT?	No
Yes	Landing Length (in)	64.0	Yes	DWS Provided?	Yes
Yes	Landing Width (in)	72.0	Yes	DWS Contrast?	Yes
No	Landing Slope (%)	2.3	Yes	DWS Length (in)	24.0
Yes	Landing X Slope (%)	0.7	Yes	DWS Full Width?	Yes
N/A	Landing Curb? (Y/N)	N/A	Yes	DWS Offset LT (in)	60.0
N/A	Shared Landing?	No	No	DWS Offset RT (in)	3.0
No	Gutter Ponding?	Yes	Yes	Gutter Slope (%)	0.4
Yes	Gutter Lip Ht (in)	0.0	Yes	Gutter X Slope (%)	1.8
N/A	Painted X Walk1?	No		Road Slope (%)	2.4
	X Walk 1 Direction	To N		Road X Slope (%)	2.0
	X Walk 1 Width (in)	N/A		Clear Space?	Yes

X Walk 1 Slope (%)	2.4	N/A	Clear Space to XWalk (in)	N/A
	X Walk 1 X Slope (%)	2.0	Yes	Storm Grate/Utility Hazard?	No
N/A	Ramp inside XWalk1?	N/A		Storm Grate/Utility Type	
Yes	Any Obstructions?	No			N/A
	Obstruction Type		Yes	Surface Condition? (G/P)	Good
			N/A	Curb Slope (%)	11.7

Possible Solutions:

Remove & Replace Entire Ramp.
