Access Compliance Report

Public Rights-of-Way

(Curb Ramps)

Intersection ID: 5501	Main Street: BRACHNELL_VIEW_DR	Cross Street: MALLARD_PARK_DR	Location: S
ADA ID: 59F5CA33FDF4	Ramp Type: Perp	Initial Pass/Fail: Fail	Overall Compliance: No
Severity Score: 12.5			
Codes/Mitigation Info/Possible Solution		Field Measurements/Component Compliance

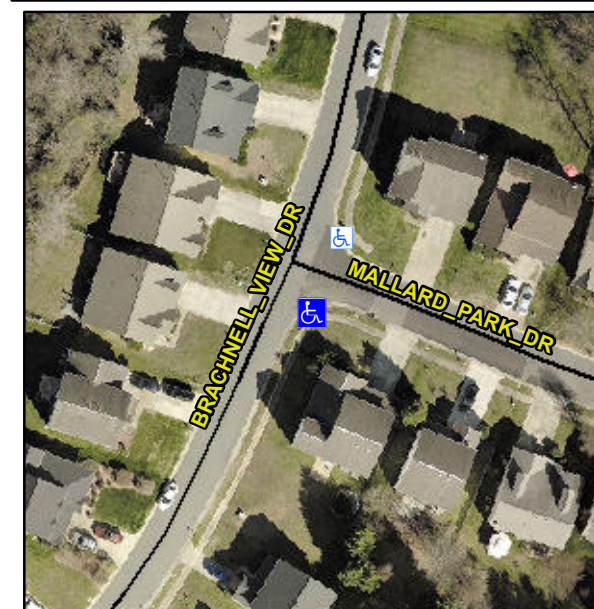
Not Found, R304.2.2

Compliance	Description	Data	Compliance	Description	Data
N/A	Ramp Length (in)	51.0	No	Ramp Slope (%)	8.7
Yes	Ramp Width (in)	50.0	Yes	Ramp XSlope (%)	1.8
N/A	Flare Type LT	N/A	N/A	Flare Type RT	N/A
N/A	Flare Slope LT (%)	N/A	N/A	Flare Slope RT (%)	N/A
N/A	Flare Traversable LT?	N/A	N/A	Flare Traversable RT?	N/A
N/A	Landing Length (in)	N/A	N/A	DWS Provided?	N/A
N/A	Landing Width (in)	N/A	N/A	DWS Contrast?	N/A
N/A	Landing Slope (%)	N/A	N/A	DWS Length (in)	N/A
N/A	Landing X Slope (%)	N/A	N/A	DWS Full Width?	N/A
N/A	Landing Curb? (Y/N)	N/A	N/A	DWS Offset (in)	N/A
N/A	Shared Landing?	N/A			
N/A	Gutter Ponding?	N/A	N/A	Gutter Slope (%)	N/A
N/A	Gutter Lip Ht (in)	N/A	N/A	Gutter X Slope (%)	N/A
N/A	Painted X Walk1?	No	N/A	Painted X Walk2?	N/A
	X Walk 1 Direction	To NE		X Walk 2 Direction	N/A
N/A	X Walk 1 Width (in)	N/A	N/A	X Walk 2 Width (in)	N/A
	X Walk 1 Slope (%)	0.3		X Walk 2 Slope (%)	N/A
	X Walk 1 X Slope (%)	1.6		X Walk 2 X Slope (%)	N/A

Possible Solutions:

Remove & Replace Entire Ramp.

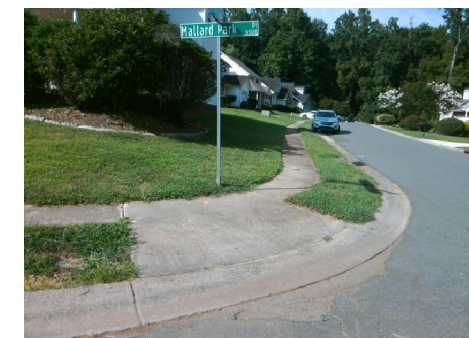
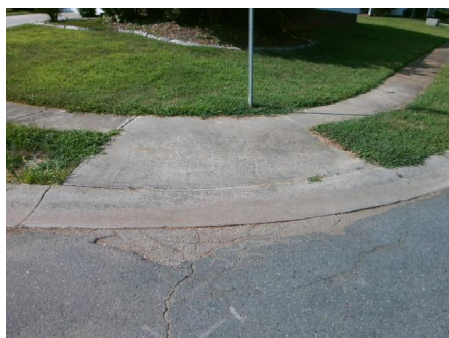
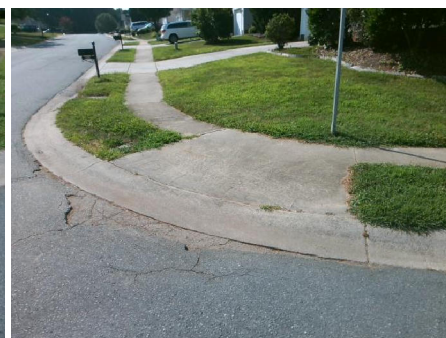
N/A	Ramp inside XWalk1?	N/A	N/A	Ramp inside XWalk2?	N/A
	Road Slope (%)	N/A	N/A	Clear Space?	N/A
	Road X Slope (%)	N/A	N/A	Clear Space to XWalk (in)	N/A
N/A	Any Obstructions?	N/A	N/A	Storm Grate/Utility Hazard?	N/A
	Obstruction Type			Storm Grate/Utility Type	
		N/A			N/A
			Yes	Surface Condition? (G/P)	Good
