Access Compliance Report

Public Rights-of-Way

(Curb Ramps)

Intersection ID: N/A	Main Street: SHARON_AMITY_RD	Cross Street: N/A	Location: SW
ADA ID: 59FBFD7EDDFF	Ramp Type: PerpDiag	Initial Pass/Fail: Fail	Overall Compliance: No
Codes/Mitigation Info/Possible Solution		Field Measurements/Component Compliance

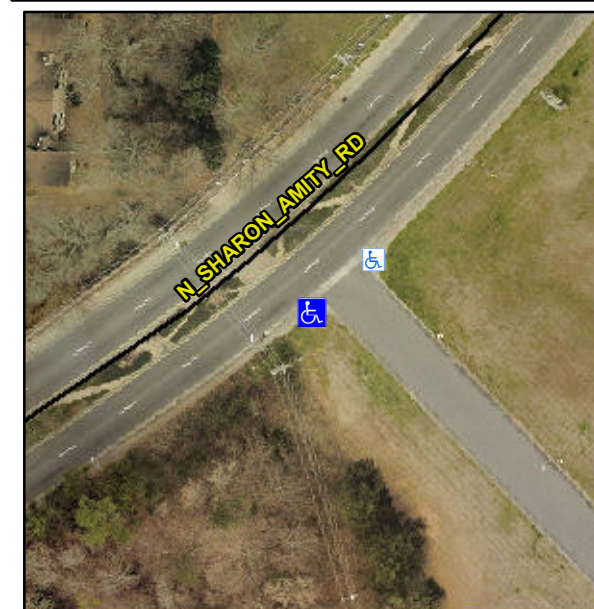
Not Found, R304.2.2, R304.5.3

Compliance	Description	Data	Compliance	Description	Data
N/A	Ramp Length (in)	61.0	No	Ramp Slope (%)	9.0
Yes	Ramp Width (in)	48.0	No	Ramp XSlope (%)	3.0
N/A	Flare Type LT	N/A	N/A	Flare Type RT	N/A
N/A	Flare Slope LT (%)	N/A	N/A	Flare Slope RT (%)	N/A
N/A	Flare Traversable LT?	N/A	N/A	Flare Traversable RT?	N/A
N/A	Landing Length (in)	N/A	N/A	DWS Provided?	N/A
N/A	Landing Width (in)	N/A	N/A	DWS Contrast?	N/A
N/A	Landing Slope (%)	N/A	N/A	DWS Length (in)	N/A
N/A	Landing X Slope (%)	N/A	N/A	DWS Full Width?	N/A
N/A	Landing Curb? (Y/N)	N/A	N/A	DWS Offset (in)	N/A
N/A	Shared Landing?	N/A			
N/A	Gutter Ponding?	N/A	N/A	Gutter Slope (%)	N/A
N/A	Gutter Lip Ht (in)	N/A	N/A	Gutter X Slope (%)	N/A
N/A	Painted X Walk1?	No	N/A	Painted X Walk2?	No
	X Walk 1 Direction	To NE		X Walk 2 Direction	To N
N/A	X Walk 1 Width (in)	N/A	N/A	X Walk 2 Width (in)	N/A
	X Walk 1 Slope (%)	2.9		X Walk 2 Slope (%)	0.1
	X Walk 1 X Slope (%)	4.9		X Walk 2 X Slope (%)	0.4

N/A	Ramp inside XWalk1?	N/A	N/A	Ramp inside XWalk2?	N/A
	Road Slope (%)	2.1	N/A	Clear Space?	N/A
	Road X Slope (%)	0.0	N/A	Clear Space to XWalk (in)	N/A
N/A	Any Obstructions?	N/A	N/A	Storm Grate/Utility Hazard?	N/A
	Obstruction Type			Storm Grate/Utility Type	
		N/A			N/A
			Yes	Surface Condition? (G/P)	Good

Remove & Replace Curb Ramp With Two New Directional Ramps or Equivalent.
