Access Compliance Report

Public Rights-of-Way

(Curb Ramps)

Intersection ID: 6653	Main Street: TYNER_ST	Cross Street: N/A	Location: S
ADA ID: 5A020DF0B057	Ramp Type: Directional1	Initial Pass/Fail: Pass	Overall Compliance: No
		Severity Score: 0

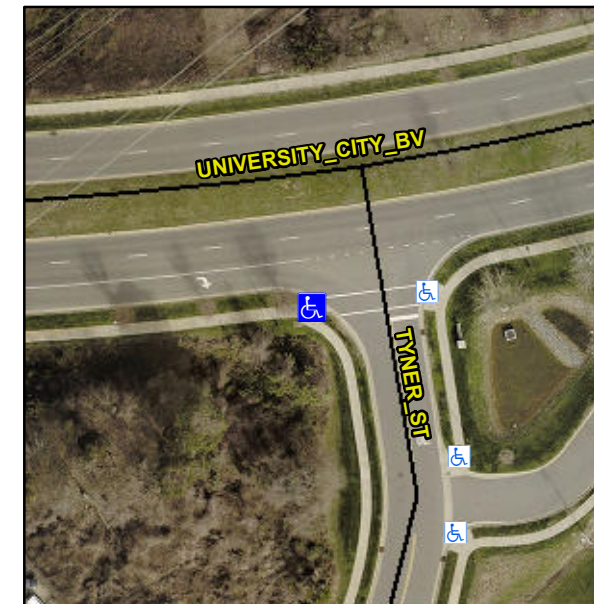
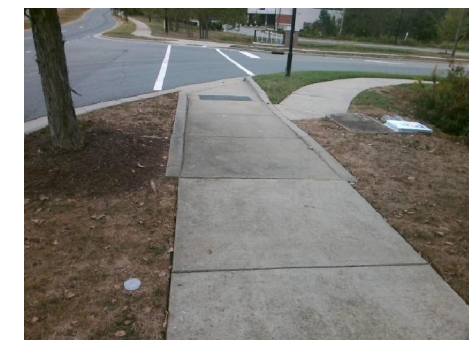
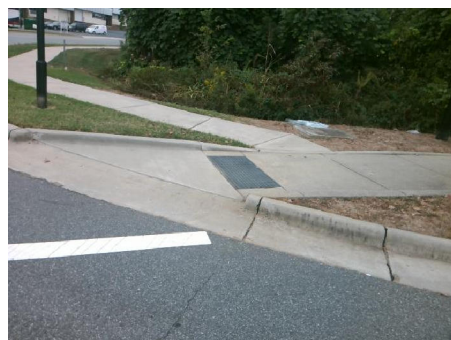
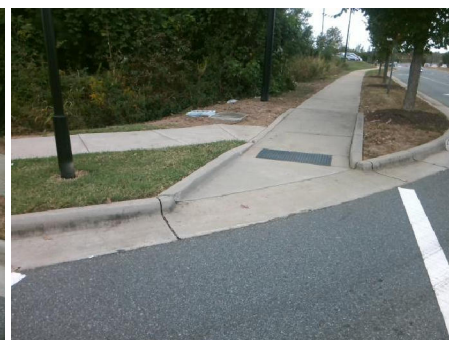
Compliance	Description	Data	Compliance	Description	Data
N/A	Ramp Length (in)	210.0	Yes	Grade Break?	Yes
Yes	Ramp Width (in)	70.0	Yes	Grade Break Slope (%)	0.9
Yes	Ramp Slope (%)	4.8	Yes	Grade Break XSlope (%)	0.9
Yes	Ramp XSlope (%)	0.4			
Yes	Flare Type LT	N/A	Yes	Flare Type RT	N/A
N/A	Flare Slope LT (%)	N/A	N/A	Flare Slope RT (%)	N/A
N/A	Flare Traversable LT?	No	N/A	Flare Traversable RT?	No
Yes	Landing Length (in)	58.0	Yes	DWS Provided?	Yes
Yes	Landing Width (in)	72.0	Yes	DWS Contrast?	Yes
Yes	Landing Slope (%)	0.5	Yes	DWS Length (in)	24.0
Yes	Landing X Slope (%)	0.8	Yes	DWS Full Width?	Yes
N/A	Landing Curb? (Y/N)	N/A	No	DWS Offset LT (in)	85.0
N/A	Shared Landing?	No	No	DWS Offset RT (in)	4.0
Yes	Gutter Ponding?	No	Yes	Gutter Slope (%)	2.8
Yes	Gutter Lip Ht (in)	0.0	Yes	Gutter X Slope (%)	0.2
N/A	Painted X Walk1?	Yes		Road Slope (%)	1.5
	X Walk 1 Direction	To NE		Road X Slope (%)	2.3
	X Walk 1 Width (in)	114.0		Clear Space?	Yes

X Walk 1 Slope (%)	1.5	N/A	Clear Space to XWalk (in)	N/A
	X Walk 1 X Slope (%)	2.3	Yes	Storm Grate/Utility Hazard?	No
No	Ramp inside XWalk1?	No		Storm Grate/Utility Type	
Yes	Any Obstructions?	No			N/A
	Obstruction Type		Yes	Surface Condition? (G/P)	Good
			N/A	Curb Slope (%)	5.4

Remove & Replace Detectable Warning System. Restripe Crosswalk.
