Access Compliance Report

Public Rights-of-Way

(Curb Ramps)

Intersection ID: N/A	Main Street: E MARTIN LUTHER KING JR BV	Cross Street: S CALDWELL ST	Location: NW
ADA ID: 5A0911BBF53C	Ramp Type: Perp	Initial Pass/Fail: Pass	Overall Compliance: No
Severity Score: 5.25			
Codes/Mitigation Info/Possible Solution		Field Measurements/Component Compliance

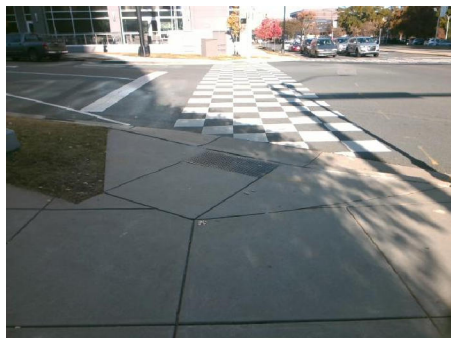
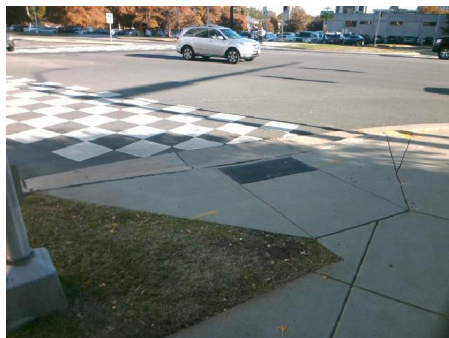
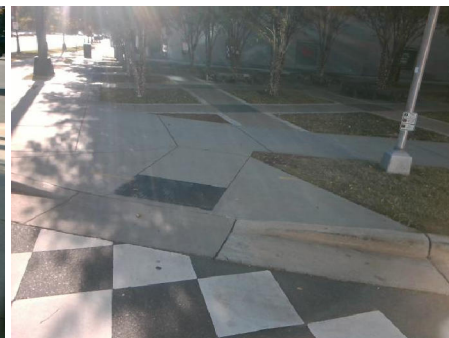
**Not Found, R304.5.3, R305.2,
R304.5.4**

Compliance	Description	Data	Compliance	Description	Data
N/A	Ramp Length (in)	83.0	Yes	Ramp Slope (%)	5.2
Yes	Ramp Width (in)	48.0	No	Ramp XSlope (%)	2.6
N/A	Flare Type LT	Sloped	N/A	Flare Type RT	N/A
N/A	Flare Slope LT (%)	5.0	N/A	Flare Slope RT (%)	8.4
N/A	Flare Traversable LT?	Yes	N/A	Flare Traversable RT?	No
Yes	Landing Length (in)	60.0	Yes	DWS Provided?	Yes
Yes	Landing Width (in)	60.0	Yes	DWS Contrast?	Yes
Yes	Landing Slope (%)	1.8	Yes	DWS Length (in)	24.5
Yes	Landing X Slope (%)	1.6	Yes	DWS Full Width?	Yes
N/A	Landing Curb? (Y/N)	No	No	DWS Offset (in)	4.5
N/A	Shared Landing?	No			
Yes	Gutter Ponding?	No	No	Gutter Slope (%)	6.9
Yes	Gutter Lip Ht (in)	0.0	No	Gutter X Slope (%)	3.6
N/A	Painted X Walk1?	Yes	N/A	Painted X Walk2?	N/A
	X Walk 1 Direction	To NE		X Walk 2 Direction	N/A
N/A	X Walk 1 Width (in)	144.0	N/A	X Walk 2 Width (in)	N/A
	X Walk 1 Slope (%)	2.7		X Walk 2 Slope (%)	N/A
	X Walk 1 X Slope (%)	1.4		X Walk 2 X Slope (%)	N/A

Yes	Ramp inside XWalk1?	Yes	N/A	Ramp inside XWalk2?	N/A
	Road Slope (%)	N/A	N/A	Clear Space?	Yes
	Road X Slope (%)	N/A	N/A	Clear Space to XWalk (in)	N/A
Yes	Any Obstructions?	No	Yes	Storm Grate/Utility Hazard?	No
	Obstruction Type			Storm Grate/Utility Type	
		N/A			N/A
			Yes	Surface Condition? (G/P)	Good

**Remove & Replace Entire Ramp.
Remove & Replace Gutter.**
