Access Compliance Report

Public Rights-of-Way (Curb Ramps)

Intersection ID: 7211	Main Street: KINGVILLE_DR	Cross Street: NORTHRIDGE_VILLAGE_DR	Location: SE
ADA ID: 5A0FB91FC983	Ramp Type: Directional1	Initial Pass/Fail: Fail	Overall Compliance: No
		Severity Score: 22.5

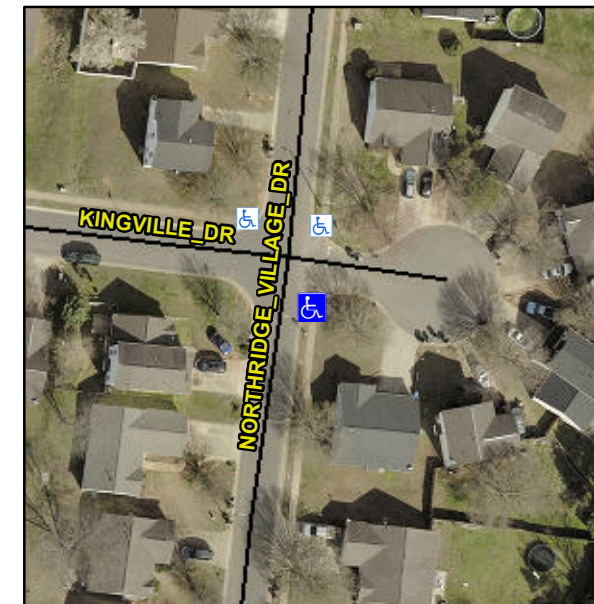
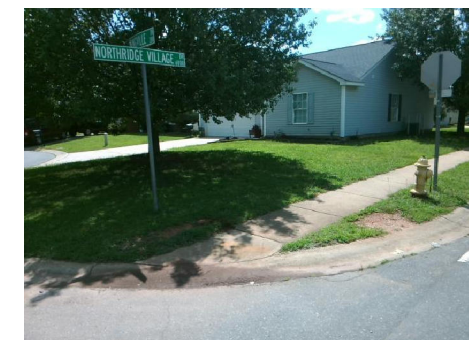
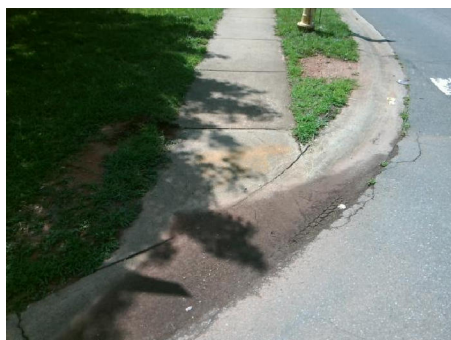
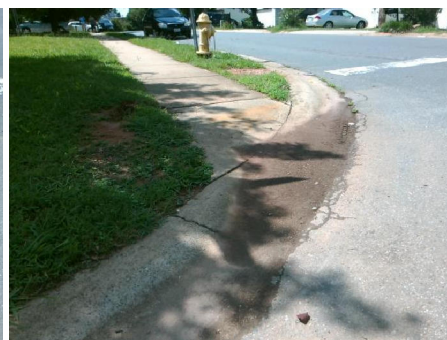
R304.5.1, R304.2.2, R304.5.3

Compliance	Description	Data	Compliance	Description	Data
N/A	Ramp Length (in)	16.5	N/A	Grade Break?	N/A
No	Ramp Width (in)	47.0	N/A	Grade Break Slope (%)	0.0
No	Ramp Slope (%)	10.8	N/A	Grade Break XSlope (%)	0.0
No	Ramp XSlope (%)	3.3			
N/A	Flare Type LT	N/A	N/A	Flare Type RT	N/A
N/A	Flare Slope LT (%)	N/A	N/A	Flare Slope RT (%)	0.0
N/A	Flare Traversable LT?	N/A	N/A	Flare Traversable RT?	N/A
N/A	Landing Length (in)	0.0	N/A	DWS Provided?	N/A
N/A	Landing Width (in)	0.0	N/A	DWS Contrast?	N/A
N/A	Landing Slope (%)	0.0	N/A	DWS Length (in)	N/A
N/A	Landing X Slope (%)	0.0	N/A	DWS Full Width?	N/A
N/A	Landing Curb? (Y/N)	N/A	N/A	DWS Offset LT (in)	N/A
N/A	Shared Landing?	N/A	N/A	DWS Offset RT (in)	N/A
N/A	Gutter Ponding?	Yes	N/A	Gutter Slope (%)	N/A
N/A	Gutter Lip Ht (in)	0.0	N/A	Gutter X Slope (%)	N/A
N/A	Painted X Walk1?	No		Road Slope (%)	0.4
	X Walk 1 Direction	To NE		Road X Slope (%)	1.7
	X Walk 1 Width (in)	N/A		Clear Space?	N/A

X Walk 1 Slope (%)	0.4	N/A	Clear Space to XWalk (in)	N/A
	X Walk 1 X Slope (%)	1.7	N/A	Storm Grate/Utility Hazard?	N/A
N/A	Ramp inside XWalk1?	N/A		Storm Grate/Utility Type	
N/A	Any Obstructions?	N/A			N/A
	Obstruction Type		Yes	Surface Condition? (G/P)	Good
			N/A	Curb Slope (%)	15.2

Remove & Replace Entire Ramp.
