Intersection ID: 25147	Main Street: CARMEL_ESTATES_RD	Cross Street: REA_RD	Location:	NW
ADA ID: 5A133469CEEC	Ramp Type: Perp	Initial Pass/Fail: Fail	Overall Compliance: No	Severity Score: 12.5

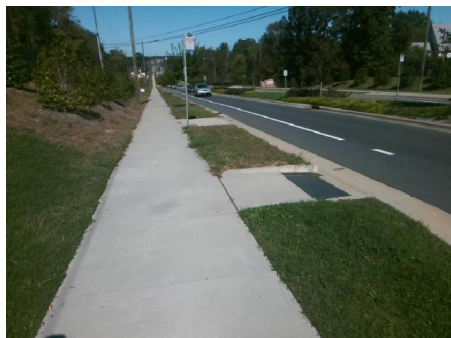
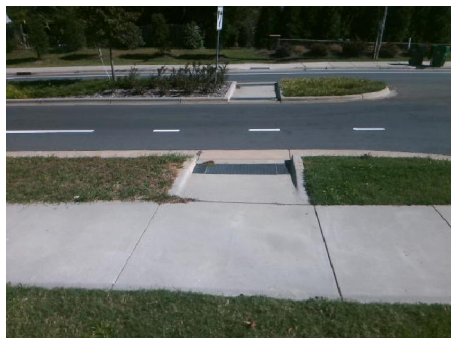
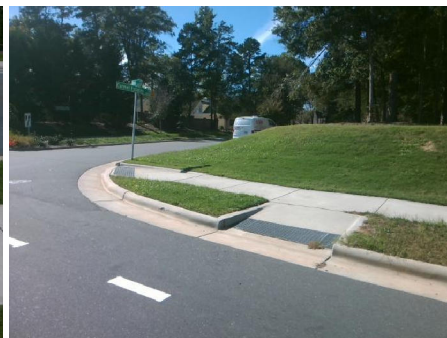
Possible Solutions:		Compliance	Description	Data	Compliance	Description	Data
	Remove & Replace Entire Ramp.		N/A	Ramp Length (in)	71.0	Yes	Ramp Slope (%)	6.0
			Yes	Ramp Width (in)	65.0	No	Ramp XSlope (%)	5.7
			N/A	Flare Type LT	N/A	N/A	Flare Type RT	N/A
			N/A	Flare Slope LT (%)	N/A	N/A	Flare Slope RT (%)	N/A
			N/A	Flare Traversable LT?	N/A	N/A	Flare Traversable RT?	N/A
			N/A	Landing Length (in)	N/A	N/A	DWS Provided?	N/A
Surveyor Notes:			N/A	Landing Width (in)	N/A	N/A	DWS Contrast?	N/A
	N/A		N/A	Landing Slope (%)	N/A	N/A	DWS Length (in)	N/A
			N/A	Landing X Slope (%)	N/A	N/A	DWS Full Width?	N/A
			N/A	Landing Curb? (Y/N)	N/A	N/A	DWS Offset (in)	N/A
			N/A	Shared Landing?	N/A			
PROW/ADA:			N/A	Gutter Ponding?	N/A	N/A	Gutter Slope (%)	N/A
	R304.5.3		N/A	Gutter Lip Ht (in)	N/A	N/A	Gutter X Slope (%)	N/A
			N/A	Painted X Walk1?	No	N/A	Painted X Walk2?	N/A

X Walk 1 Direction	To E		X Walk 2 Direction	N/A
			N/A	X Walk 1 Width (in)	N/A	N/A	X Walk 2 Width (in)	N/A
				X Walk 1 Slope (%)	1.5		X Walk 2 Slope (%)	N/A
				X Walk 1 X Slope (%)	5.7		X Walk 2 X Slope (%)	N/A
			N/A	Ramp inside XWalk1?	N/A	N/A	Ramp inside XWalk2?	N/A
				Road Slope (%)	N/A	N/A	Clear Space?	N/A
				Road X Slope (%)	N/A	N/A	Clear Space to XWalk (in)	N/A
			N/A	Any Obstructions?	N/A	N/A	Storm Grate/Utility Hazard?	N/A
				Obstruction Type			Storm Grate/Utility Type	
Total Cost:	\$ 1850.00				N/A			N/A
						Yes	Surface Condition? (G/P)	Good
