Access Compliance Report

Public Rights-of-Way

(Curb Ramps)

Intersection ID: 13540	Main Street: LEXINGTON_AV	Cross Street: S_CALDWELL_ST	Location: W
ADA ID: 5A13C2A75B27	Ramp Type: PerpDiag	Initial Pass/Fail: Fail	Overall Compliance: No
			Severity Score: 13.75

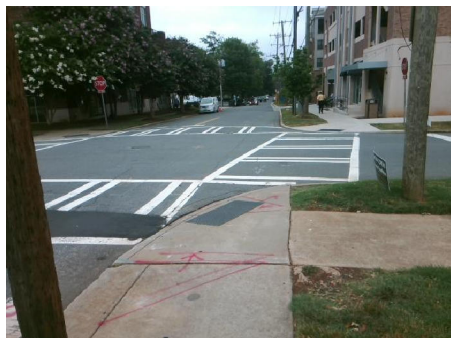
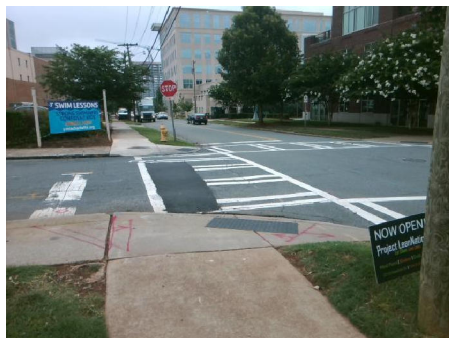
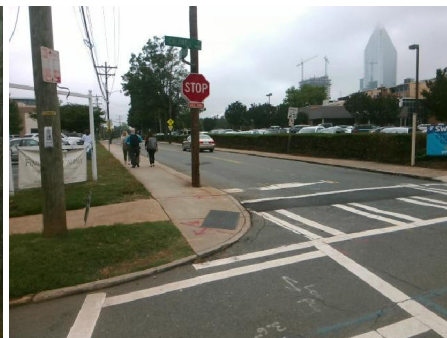
Compliance	Description	Data	Compliance	Description	Data
N/A	Ramp Length (in)	51.0	No	Ramp Slope (%)	10.0
Yes	Ramp Width (in)	72.0	No	Ramp XSlope (%)	4.7
N/A	Flare Type LT	N/A	N/A	Flare Type RT	N/A
N/A	Flare Slope LT (%)	N/A	N/A	Flare Slope RT (%)	N/A
N/A	Flare Traversable LT?	N/A	N/A	Flare Traversable RT?	N/A
N/A	Landing Length (in)	N/A	N/A	DWS Provided?	N/A
N/A	Landing Width (in)	N/A	N/A	DWS Contrast?	N/A
N/A	Landing Slope (%)	N/A	N/A	DWS Length (in)	N/A
N/A	Landing X Slope (%)	N/A	N/A	DWS Full Width?	N/A
N/A	Landing Curb? (Y/N)	N/A	N/A	DWS Offset (in)	N/A
N/A	Shared Landing?	N/A			
N/A	Gutter Ponding?	N/A	N/A	Gutter Slope (%)	N/A
N/A	Gutter Lip Ht (in)	N/A	N/A	Gutter X Slope (%)	N/A
N/A	Painted X Walk1?	Yes	N/A	Painted X Walk2?	Yes
	X Walk 1 Direction	To SE		X Walk 2 Direction	To NE
N/A	X Walk 1 Width (in)	111.0	N/A	X Walk 2 Width (in)	77.0
	X Walk 1 Slope (%)	1.4		X Walk 2 Slope (%)	1.3
	X Walk 1 X Slope (%)	2.5		X Walk 2 X Slope (%)	4.2

N/A	Ramp inside XWalk1?	Yes	N/A	Ramp inside XWalk2?	Yes
	Road Slope (%)	2.5	N/A	Clear Space?	N/A
	Road X Slope (%)	1.8	N/A	Clear Space to XWalk (in)	N/A
N/A	Any Obstructions?	N/A	N/A	Storm Grate/Utility Hazard?	N/A
	Obstruction Type			Storm Grate/Utility Type	
		N/A			N/A
		Yes		Surface Condition? (G/P)	Good

Possible Solutions:

Remove & Replace Curb Ramp With Two New Directional Ramps or Equivalent.
