Access Compliance Report

Public Rights-of-Way

(Curb Ramps)

Intersection ID: 44909	Main Street: PALUSTRIS_CT	Cross Street: OAKBURN_DR	Location: NW
ADA ID: 5A143FCD7EA4	Ramp Type: PerpDiag	Initial Pass/Fail: Fail	Overall Compliance: No
Severity Score: 8.75			
Codes/Mitigation Info/Possible Solution		Field Measurements/Component Compliance

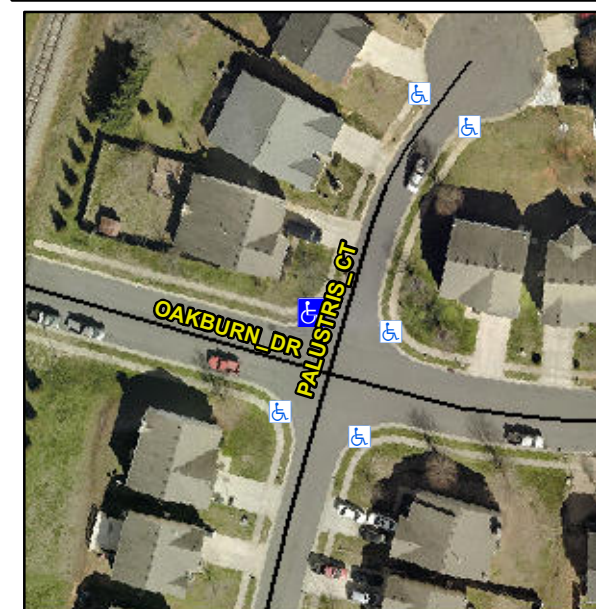
Not Found, R304.5.1

Compliance	Description	Data	Compliance	Description	Data
N/A	Ramp Length (in)	46.5	Yes	Ramp Slope (%)	8.3
No	Ramp Width (in)	43.0	Yes	Ramp XSlope (%)	1.9
N/A	Flare Type LT	N/A	N/A	Flare Type RT	N/A
N/A	Flare Slope LT (%)	N/A	N/A	Flare Slope RT (%)	N/A
N/A	Flare Traversable LT?	N/A	N/A	Flare Traversable RT?	N/A
N/A	Landing Length (in)	N/A	N/A	DWS Provided?	N/A
N/A	Landing Width (in)	N/A	N/A	DWS Contrast?	N/A
N/A	Landing Slope (%)	N/A	N/A	DWS Length (in)	N/A
N/A	Landing X Slope (%)	N/A	N/A	DWS Full Width?	N/A
N/A	Landing Curb? (Y/N)	N/A	N/A	DWS Offset (in)	N/A
N/A	Shared Landing?	N/A			
N/A	Gutter Ponding?	N/A	N/A	Gutter Slope (%)	N/A
N/A	Gutter Lip Ht (in)	N/A	N/A	Gutter X Slope (%)	N/A
N/A	Painted X Walk1?	No	N/A	Painted X Walk2?	No
	X Walk 1 Direction	To SW		X Walk 2 Direction	To SE
N/A	X Walk 1 Width (in)	N/A	N/A	X Walk 2 Width (in)	N/A
	X Walk 1 Slope (%)	0.1		X Walk 2 Slope (%)	1.4
	X Walk 1 X Slope (%)	2.1		X Walk 2 X Slope (%)	0.8

N/A	Ramp inside XWalk1?	N/A	N/A	Ramp inside XWalk2?	N/A
	Road Slope (%)	1.5	N/A	Clear Space?	N/A
	Road X Slope (%)	0.7	N/A	Clear Space to XWalk (in)	N/A
N/A	Any Obstructions?	N/A	N/A	Storm Grate/Utility Hazard?	N/A
	Obstruction Type			Storm Grate/Utility Type	
		N/A			N/A
			Yes	Surface Condition? (G/P)	Good

Possible Solutions:

Remove & Replace Curb Ramp With Two New Directional Ramps or Equivalent.
