Access Compliance Report

Public Rights-of-Way

(Curb Ramps)

Intersection ID: 49184	Main Street: ST_GERMAINE_LN	Cross Street: ST_STEPHEN_LN	Location: SW
ADA ID: 5A216B127E84	Ramp Type: Perp	Initial Pass/Fail: Fail	Overall Compliance: No
Severity Score: 13.75			
Codes/Mitigation Info/Possible Solution		Field Measurements/Component Compliance

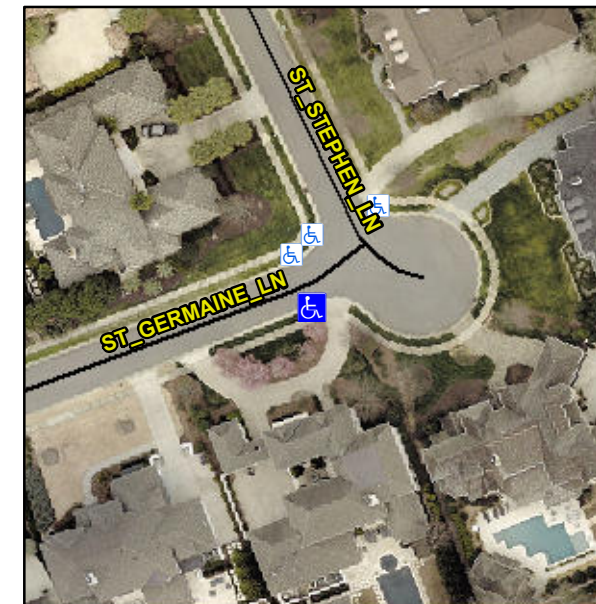
Compliance	Description	Data	Compliance	Description	Data
N/A	Ramp Length (in)	50.5	No	Ramp Slope (%)	11.1
Yes	Ramp Width (in)	48.0	Yes	Ramp XSlope (%)	3.8
N/A	Flare Type LT	N/A	N/A	Flare Type RT	N/A
N/A	Flare Slope LT (%)	N/A	N/A	Flare Slope RT (%)	N/A
N/A	Flare Traversable LT?	N/A	N/A	Flare Traversable RT?	N/A
N/A	Landing Length (in)	N/A	N/A	DWS Provided?	N/A
N/A	Landing Width (in)	N/A	N/A	DWS Contrast?	N/A
N/A	Landing Slope (%)	N/A	N/A	DWS Length (in)	N/A
N/A	Landing X Slope (%)	N/A	N/A	DWS Full Width?	N/A
N/A	Landing Curb? (Y/N)	N/A	N/A	DWS Offset (in)	N/A
N/A	Shared Landing?	N/A			
N/A	Gutter Ponding?	N/A	N/A	Gutter Slope (%)	N/A
N/A	Gutter Lip Ht (in)	N/A	N/A	Gutter X Slope (%)	N/A
N/A	Painted X Walk1?	No	N/A	Painted X Walk2?	N/A
	X Walk 1 Direction	To N		X Walk 2 Direction	N/A
N/A	X Walk 1 Width (in)	N/A	N/A	X Walk 2 Width (in)	N/A
	X Walk 1 Slope (%)	3.0		X Walk 2 Slope (%)	N/A
	X Walk 1 X Slope (%)	5.9		X Walk 2 X Slope (%)	N/A

N/A	Ramp inside XWalk1?	N/A	N/A	Ramp inside XWalk2?	N/A
	Road Slope (%)	N/A	N/A	Clear Space?	N/A
	Road X Slope (%)	N/A	N/A	Clear Space to XWalk (in)	N/A
N/A	Any Obstructions?	N/A	N/A	Storm Grate/Utility Hazard?	N/A
	Obstruction Type			Storm Grate/Utility Type	
		N/A			N/A
			Yes	Surface Condition? (G/P)	Good

Possible Solutions:

Remove & Replace Entire Ramp.

Not Found, R304.2.2
