# Access Compliance Report

## Public Rights-of-Way

### (Curb Ramps)

Intersection ID: 31220	Main Street: OAKTON_HUNT_DR	Cross Street: CAPRINGTON_AV	Location: N
ADA ID: 5A2720548354	Ramp Type: PerpDiag	Initial Pass/Fail: Fail	Overall Compliance: No
			Severity Score: 46.25

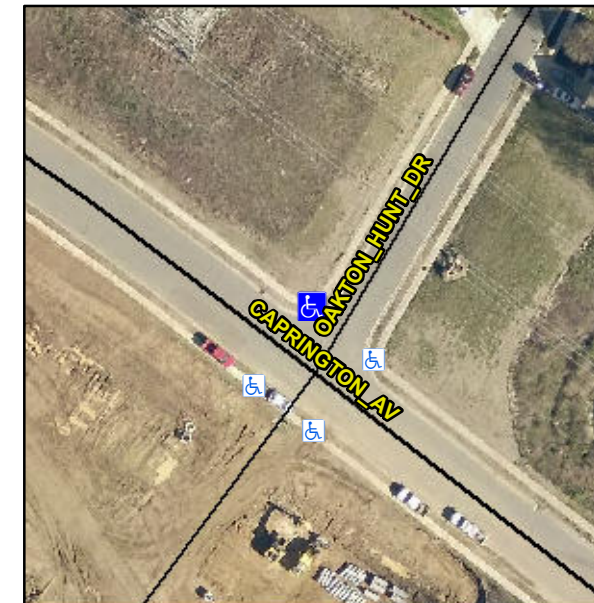
**Not Found, R304.5.1, R304.2.2, R304.5.3**

Compliance	Description	Data	Compliance	Description	Data
N/A	Ramp Length (in)	48.0	No	Ramp Slope (%)	9.3
No	Ramp Width (in)	43.0	No	Ramp XSlope (%)	11.5
N/A	Flare Type LT	N/A	N/A	Flare Type RT	N/A
N/A	Flare Slope LT (%)	N/A	N/A	Flare Slope RT (%)	N/A
N/A	Flare Traversable LT?	N/A	N/A	Flare Traversable RT?	N/A
N/A	Landing Length (in)	N/A	N/A	DWS Provided?	N/A
N/A	Landing Width (in)	N/A	N/A	DWS Contrast?	N/A
N/A	Landing Slope (%)	N/A	N/A	DWS Length (in)	N/A
N/A	Landing X Slope (%)	N/A	N/A	DWS Full Width?	N/A
N/A	Landing Curb? (Y/N)	N/A	N/A	DWS Offset (in)	N/A
N/A	Shared Landing?	N/A			
N/A	Gutter Ponding?	N/A	N/A	Gutter Slope (%)	N/A
N/A	Gutter Lip Ht (in)	N/A	N/A	Gutter X Slope (%)	N/A
N/A	Painted X Walk1?	No	N/A	Painted X Walk2?	No
	X Walk 1 Direction	To SW		X Walk 2 Direction	To SE
N/A	X Walk 1 Width (in)	N/A	N/A	X Walk 2 Width (in)	N/A
	X Walk 1 Slope (%)	5.8		X Walk 2 Slope (%)	4.9
	X Walk 1 X Slope (%)	4.2		X Walk 2 X Slope (%)	3.7

N/A	Ramp inside XWalk1?	N/A	N/A	Ramp inside XWalk2?	N/A
	Road Slope (%)	11.2	N/A	Clear Space?	N/A
	Road X Slope (%)	5.6	N/A	Clear Space to XWalk (in)	N/A
N/A	Any Obstructions?	N/A	N/A	Storm Grate/Utility Hazard?	N/A
	Obstruction Type			Storm Grate/Utility Type	
		N/A			N/A
			Yes	Surface Condition? (G/P)	Good

**Remove & Replace Curb Ramp With Two New Directional Ramps or Equivalent.**
