Access Compliance Report Public Rights-of-Way (Curb Ramps)

Intersection ID: 9578 Main Street: WOODWARD AV Cross Street: STATESVILLE_AV Location: SW **Overall Compliance: No ADA ID: 5A2AA9DD9628** Ramp Type: Perp Initial Pass/Fail: Fail **Severity Score:** 22.5

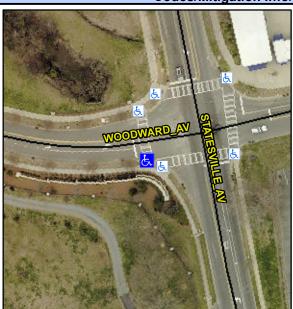
Comp	liance Description	Data	Comp	liance Description	Data
N/A	Ramp Length (in)	71.5	No	Ramp Slope (%)	8.7
No	Ramp Width (in)	44.0	No	Ramp XSlope (%)	3.4
N/A	Flare Type LT	N/A	N/A	Flare Type RT	N/A
N/A	Flare Slope LT (%)	N/A	N/A	Flare Slope RT (%)	N/A
N/A	Flare Traversable LT?	N/A	N/A	Flare Traversable RT?	N/A
N/A	Landing Length (in)	N/A	N/A	DWS Provided?	N/A
N/A	Landing Width (in)	N/A	N/A	DWS Contrast?	N/A
N/A	Landing Slope (%)	N/A	N/A	DWS Length (in)	N/A
N/A	Landing X Slope (%)	N/A	N/A	DWS Full Width?	N/A
N/A	Landing Curb? (Y/N)	N/A	N/A	DWS Offset (in)	N/A
N/A	Shared Landing?	N/A			
N/A	Gutter Ponding?	N/A	N/A	Gutter Slope (%)	N/A
N/A	Gutter Lip Ht (in)	N/A	N/A	Gutter X Slope (%)	N/A
N/A	Painted X Walk1?	No	N/A	Painted X Walk2?	N/A
	X Walk 1 Direction	To N		X Walk 2 Direction	N/A
N/A	X Walk 1 Width (in)	N/A	N/A	X Walk 2 Width (in)	N/A
	X Walk 1 Slope (%)	1.2		X Walk 2 Slope (%)	N/A
	X Walk 1 X Slope (%)	2.1		X Walk 2 X Slope (%)	N/A

N/A	Ramp inside XWalk1?	N/A	N/A	Ramp inside XWalk2?	N/A
	Road Slope (%)	N/A	N/A	Clear Space?	N/A
	Road X Slope (%)	N/A	N/A	Clear Space to XWalk (in)	N/A
N/A	Any Obstructions?	N/A	N/A	Storm Grate/Utility Hazard	? N/A
	Obstruction Type			Storm Grate/Utility Type	
		N/A			N/A
			Yes	Surface Condition? (G/P)	Good

Remove & Replace Entire Ramp.
Surveyor Notes:
N/A
N/A
PROW/ADA:
Not Found, R304.5.1, R304.2.2,
R304.5.3

N
Surveyor Notes:			N
N/A			N
			N
			N
			N
PROW/ADA:			N
Not Found,	R304.5.1, R304.2.2,		N.
R304.5.3			N
			N
			N
			N
Total Cost:	\$	1850.00
