Access Compliance Report

(Curb Ramps)

Intersection ID: 30464	Main Street: BUBBLING_BROOK_CT	Cross Street: PLANTERS_ROW_DR	Location: SE
ADA ID: 5A2FBEA5C1D2	Ramp Type: PerpDiag	Initial Pass/Fail: Fail	Overall Compliance: No
Severity Score: 22.5			
Codes/Mitigation Info/Possible Solution		Field Measurements/Component Compliance

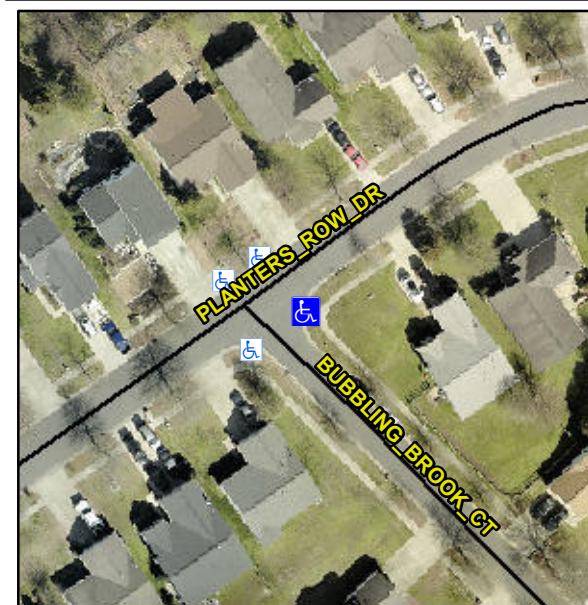
Not Found, R304.5.1, R304.2.2, R304.5.3

Compliance	Description	Data	Compliance	Description	Data
N/A	Ramp Length (in)	86.0	No	Ramp Slope (%)	11.3
No	Ramp Width (in)	47.5	No	Ramp XSlope (%)	2.8
N/A	Flare Type LT	N/A	N/A	Flare Type RT	N/A
N/A	Flare Slope LT (%)	N/A	N/A	Flare Slope RT (%)	N/A
N/A	Flare Traversable LT?	N/A	N/A	Flare Traversable RT?	N/A
N/A	Landing Length (in)	N/A	N/A	DWS Provided?	N/A
N/A	Landing Width (in)	N/A	N/A	DWS Contrast?	N/A
N/A	Landing Slope (%)	N/A	N/A	DWS Length (in)	N/A
N/A	Landing X Slope (%)	N/A	N/A	DWS Full Width?	N/A
N/A	Landing Curb? (Y/N)	N/A	N/A	DWS Offset (in)	N/A
N/A	Shared Landing?	N/A			
N/A	Gutter Ponding?	N/A	N/A	Gutter Slope (%)	N/A
N/A	Gutter Lip Ht (in)	N/A	N/A	Gutter X Slope (%)	N/A
N/A	Painted X Walk1?	No	N/A	Painted X Walk2?	No
	X Walk 1 Direction	To NW		X Walk 2 Direction	To SW
N/A	X Walk 1 Width (in)	N/A	N/A	X Walk 2 Width (in)	N/A
	X Walk 1 Slope (%)	2.6		X Walk 2 Slope (%)	1.5
	X Walk 1 X Slope (%)	0.8		X Walk 2 X Slope (%)	1.5

Possible Solutions:

Remove & Replace Curb Ramp With Two New Directional Ramps or Equivalent.

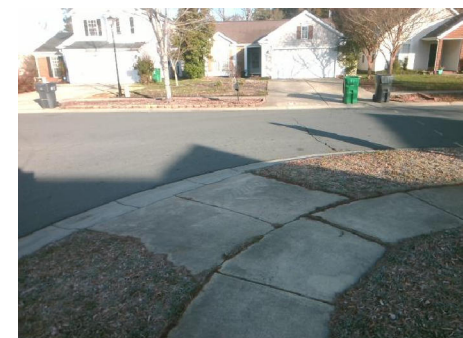
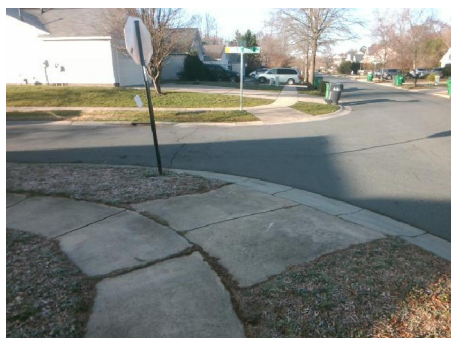
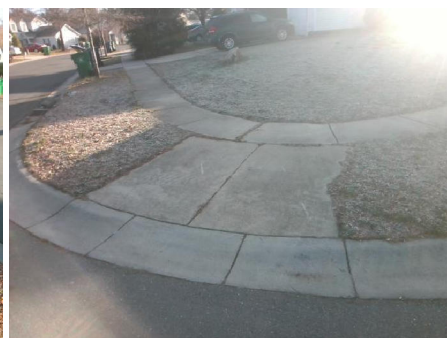
N/A	Ramp inside XWalk1?	N/A	N/A	Ramp inside XWalk2?	N/A
	Road Slope (%)	1.4	N/A	Clear Space?	N/A
	Road X Slope (%)	1.3	N/A	Clear Space to XWalk (in)	N/A
N/A	Any Obstructions?	N/A	N/A	Storm Grate/Utility Hazard?	N/A
	Obstruction Type			Storm Grate/Utility Type	
		N/A			N/A
			Yes	Surface Condition? (G/P)	Good
