## Access Compliance Report Public Rights-of-Way (Curb Ramps)

Intersection ID: 20439 Main Street: FAIRVIEW\_RD Cross Street: SHARON\_RD Location: SW

ADA ID: 5A30BF257B75 Ramp Type: Perp Initial Pass/Fail: Fail Overall Compliance: No Severity Score: 13.75

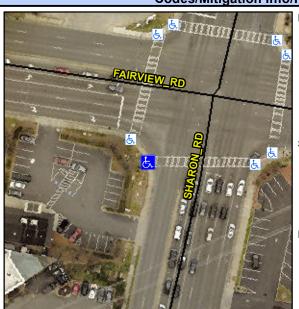
ass/F	ali: Fali Overali i	Compilar	ce: N	o Severity Score:	13.7				
Field Measurements/Component Compliance									
Comp	liance Description	Data	Comp	liance Description	Data				
N/A	Ramp Length (in)	60.0	No	Ramp Slope (%)	9.1				
Yes	Ramp Width (in)	48.0	No	Ramp XSlope (%)	4.2				
N/A	Flare Type LT	N/A	N/A	Flare Type RT	N/A				
N/A	Flare Slope LT (%)	N/A	N/A	Flare Slope RT (%)	N/A				
N/A	Flare Traversable LT?	N/A	N/A	Flare Traversable RT?	N/A				
N/A	Landing Length (in)	N/A	N/A	DWS Provided?	N/A				
N/A	Landing Width (in)	N/A	N/A	DWS Contrast?	N/A				
N/A	Landing Slope (%)	N/A	N/A	DWS Length (in)	N/A				
N/A	Landing X Slope (%)	N/A	N/A	DWS Full Width?	N/A				
N/A	Landing Curb? (Y/N)	N/A	N/A	DWS Offset (in)	N/A				
N/A	Shared Landing?	N/A							
N/A	Gutter Ponding?	N/A	N/A	Gutter Slope (%)	N/A				
N/A	Gutter Lip Ht (in)	N/A	N/A	Gutter X Slope (%)	N/A				
N/A	Painted X Walk1?	Yes	N/A	Painted X Walk2?	N/A

X Walk 1 Direction	To SE		X Walk 2 Direction	N/A				
N/A	X Walk 1 Width (in)	116.0	N/A	X Walk 2 Width (in)	N/A				
	X Walk 1 Slope (%)	4.2		X Walk 2 Slope (%)	N/A				
	X Walk 1 X Slope (%)	1.9		X Walk 2 X Slope (%)	N/A				
N/A	Ramp inside XWalk1?	Yes	N/A	Ramp inside XWalk2?	N/A				
	Road Slope (%)	N/A	N/A	Clear Space?	N/A				
	Road X Slope (%)	N/A	N/A	Clear Space to XWalk (in)	N/A				
N/A	Any Obstructions?	N/A	N/A	Storm Grate/Utility Hazard?	N/A				
	Obstruction Type			Storm Grate/Utility Type					
		N/A			N/A				
			Yes	Surface Condition? (G/P)	Good

Possible Solutions:	<u>c</u>	
Remove & Replace Entire Ramp.		
	Υ	
	N	
	N	
	N	
	N	
Surveyor Notes:	N	
N/A	N	
	N	
	N	
	N	
PROW/ADA:	N	
Not Found, R304.2.2, R304.5.3	N	
	N	
	N	
	N
