# Access Compliance Report

## Public Rights-of-Way

### (Curb Ramps)

Intersection ID: 31907	Main Street: PALOMAR_MOUNTAIN_DR	Cross Street: SPRUCE_PEAK_RD	Location: NE
ADA ID: 5A470CD7B19B	Ramp Type: PerpDiag	Initial Pass/Fail: Fail	Overall Compliance: No
Severity Score: 33.75			
Codes/Mitigation Info/Possible Solution		Field Measurements/Component Compliance

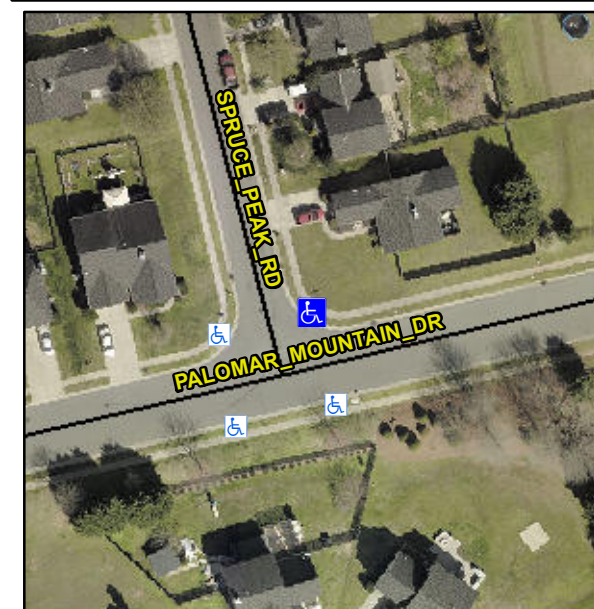
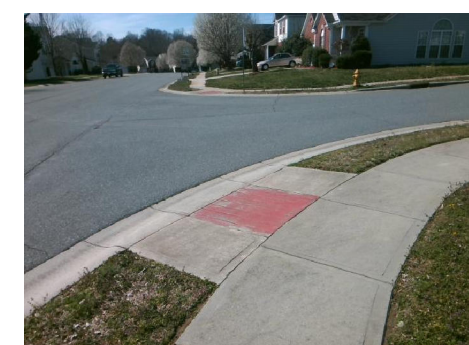
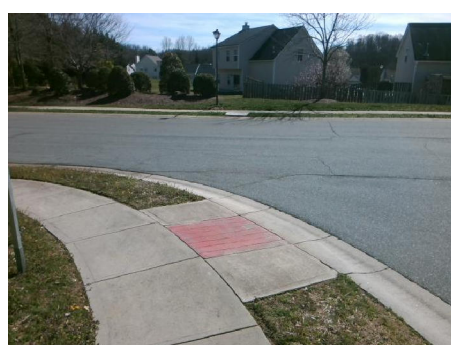
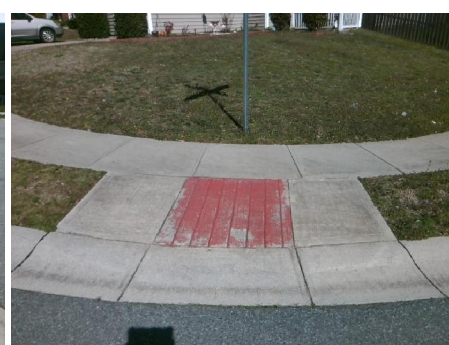
Compliance	Description	Data	Compliance	Description	Data
N/A	Ramp Length (in)	48.0	No	Ramp Slope (%)	10.4
No	Ramp Width (in)	47.0	No	Ramp XSlope (%)	5.3
N/A	Flare Type LT	N/A	N/A	Flare Type RT	N/A
N/A	Flare Slope LT (%)	N/A	N/A	Flare Slope RT (%)	N/A
N/A	Flare Traversable LT?	N/A	N/A	Flare Traversable RT?	N/A
N/A	Landing Length (in)	N/A	N/A	DWS Provided?	N/A
N/A	Landing Width (in)	N/A	N/A	DWS Contrast?	N/A
N/A	Landing Slope (%)	N/A	N/A	DWS Length (in)	N/A
N/A	Landing X Slope (%)	N/A	N/A	DWS Full Width?	N/A
N/A	Landing Curb? (Y/N)	N/A	N/A	DWS Offset (in)	N/A
N/A	Shared Landing?	N/A			
N/A	Gutter Ponding?	N/A	N/A	Gutter Slope (%)	N/A
N/A	Gutter Lip Ht (in)	N/A	N/A	Gutter X Slope (%)	N/A
N/A	Painted X Walk1?	No	N/A	Painted X Walk2?	No
	X Walk 1 Direction	To W		X Walk 2 Direction	To S
N/A	X Walk 1 Width (in)	N/A	N/A	X Walk 2 Width (in)	N/A
	X Walk 1 Slope (%)	1.3		X Walk 2 Slope (%)	0.8
	X Walk 1 X Slope (%)	3.3		X Walk 2 X Slope (%)	2.6

N/A	Ramp inside XWalk1?	N/A	N/A	Ramp inside XWalk2?	N/A
	Road Slope (%)	3.4	N/A	Clear Space?	N/A
	Road X Slope (%)	1.0	N/A	Clear Space to XWalk (in)	N/A
N/A	Any Obstructions?	N/A	N/A	Storm Grate/Utility Hazard?	N/A
	Obstruction Type			Storm Grate/Utility Type	
		N/A			N/A
			Yes	Surface Condition? (G/P)	Good

**Remove & Replace Curb Ramp With Two New Directional Ramps or Equivalent.**
