# Access Compliance Report

## Public Rights-of-Way

### (Curb Ramps)

Intersection ID: 4562	Main Street: MALLARD_CREEK_RD	Cross Street: SUMMERCROFT_LN	Location: NW
ADA ID: 5A4AFA6C84B8	Ramp Type: Perp	Initial Pass/Fail: Fail	Overall Compliance: No
Severity Score: 21.25			
Codes/Mitigation Info/Possible Solution		Field Measurements/Component Compliance

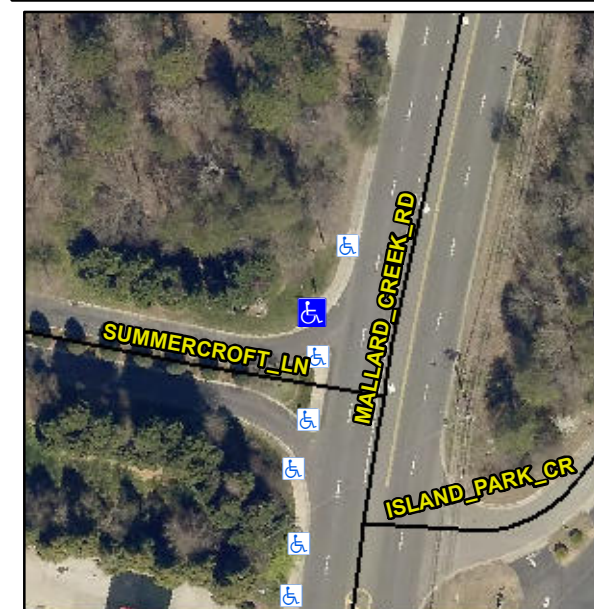
**Not Found, R304.5.1, R304.5.3**

Compliance	Description	Data	Compliance	Description	Data
N/A	Ramp Length (in)	60.0	Yes	Ramp Slope (%)	7.0
No	Ramp Width (in)	42.0	No	Ramp XSlope (%)	5.3
N/A	Flare Type LT	N/A	N/A	Flare Type RT	N/A
N/A	Flare Slope LT (%)	N/A	N/A	Flare Slope RT (%)	N/A
N/A	Flare Traversable LT?	N/A	N/A	Flare Traversable RT?	N/A
N/A	Landing Length (in)	N/A	N/A	DWS Provided?	N/A
N/A	Landing Width (in)	N/A	N/A	DWS Contrast?	N/A
N/A	Landing Slope (%)	N/A	N/A	DWS Length (in)	N/A
N/A	Landing X Slope (%)	N/A	N/A	DWS Full Width?	N/A
N/A	Landing Curb? (Y/N)	N/A	N/A	DWS Offset (in)	N/A
N/A	Shared Landing?	N/A			
N/A	Gutter Ponding?	N/A	N/A	Gutter Slope (%)	N/A
N/A	Gutter Lip Ht (in)	N/A	N/A	Gutter X Slope (%)	N/A
N/A	Painted X Walk1?	No	N/A	Painted X Walk2?	N/A
	X Walk 1 Direction	To S		X Walk 2 Direction	N/A
N/A	X Walk 1 Width (in)	N/A	N/A	X Walk 2 Width (in)	N/A
	X Walk 1 Slope (%)	4.1		X Walk 2 Slope (%)	N/A
	X Walk 1 X Slope (%)	0.3		X Walk 2 X Slope (%)	N/A

N/A	Ramp inside XWalk1?	N/A	N/A	Ramp inside XWalk2?	N/A
	Road Slope (%)	N/A	N/A	Clear Space?	N/A
	Road X Slope (%)	N/A	N/A	Clear Space to XWalk (in)	N/A
N/A	Any Obstructions?	N/A	N/A	Storm Grate/Utility Hazard?	N/A
	Obstruction Type			Storm Grate/Utility Type	
		N/A			N/A
			Yes	Surface Condition? (G/P)	Good

**Remove & Replace Entire Ramp.**
