Access Compliance Report

Public Rights-of-Way

(Curb Ramps)

Intersection ID: 12066	Main Street: WEYLAND_AV	Cross Street: MARLOWE_AV	Location: SW
ADA ID: 5A5724C29B30	Ramp Type: PerpDiag	Initial Pass/Fail: Fail	Overall Compliance: No
Codes/Mitigation Info/Possible Solution		Field Measurements/Component Compliance

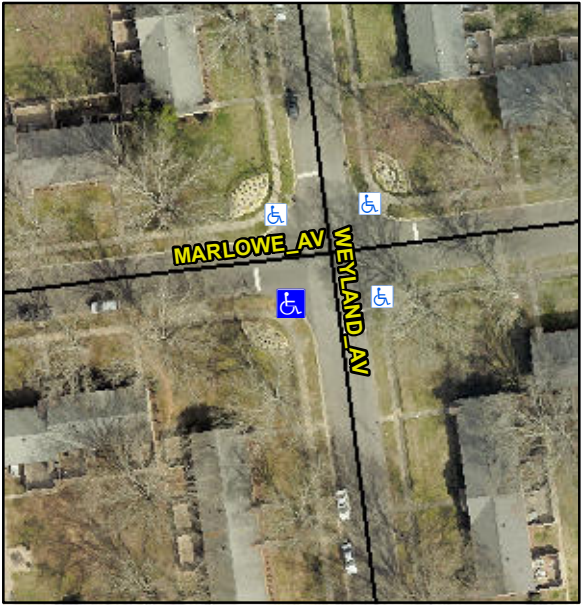
Possible Solutions:						
	Remove & Replace Curb Ramp With Two New Directional Ramps or Equivalent.						
	Surveyor Notes:						
	N/A						
	PROW/ADA:						
	Not Found, R304.2.2, R304.5.3						
Street 1 Name	WAYLAND AV	Compliance	Description	Data	Compliance	Description	Data
Stop Condition-Street 2	StopSign	N/A	Ramp Length (in)	82.0	No	Ramp Slope (%)	9.5
Street 2 Name	MARLOWE AV	Yes	Ramp Width (in)	50.0	No	Ramp XSlope (%)	2.7
Stop Condition-Street 1	StopSign	N/A	Flare Type LT	N/A	N/A	Flare Type RT	N/A
		N/A	Flare Slope LT (%)	N/A	N/A	Flare Slope RT (%)	N/A
		N/A	Flare Traversable LT?	N/A	N/A	Flare Traversable RT?	N/A
		N/A	Landing Length (in)	N/A	N/A	DWS Provided?	N/A
		N/A	Landing Width (in)	N/A	N/A	DWS Contrast?	N/A
		N/A	Landing Slope (%)	N/A	N/A	DWS Length (in)	N/A
		N/A	Landing X Slope (%)	N/A	N/A	DWS Full Width?	N/A
		N/A	Landing Curb? (Y/N)	N/A	N/A	DWS Offset (in)	N/A
		N/A	Shared Landing?	N/A
