Access Compliance Report

Public Rights-of-Way

(Curb Ramps)

Intersection ID: 20760	Main Street: SHARON_RD	Cross Street: SHARON_VIEW_RD	Location: SE
ADA ID: 5A5A5B672AA5	Ramp Type: MedianPerp	Initial Pass/Fail: Fail	Overall Compliance: No
			Severity Score: 13.75

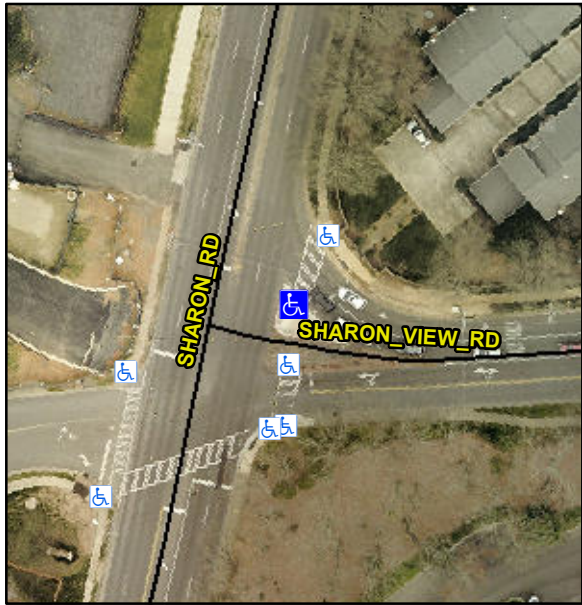
Possible Solutions:		Compliance	Description	Data	Compliance	Description	Data
	Remove & Replace Entire Ramp.		N/A	Ramp Length (in)	48.0	No	Ramp Slope (%)	9.0
			Yes	Ramp Width (in)	48.0	No	Ramp XSlope (%)	4.7
			N/A	Flare Type LT	N/A	N/A	Flare Type RT	N/A
			N/A	Flare Slope LT (%)	N/A	N/A	Flare Slope RT (%)	N/A
			N/A	Flare Traversable LT?	N/A	N/A	Flare Traversable RT?	N/A
			N/A	Landing Length (in)	N/A	N/A	DWS Provided?	N/A
			N/A	Landing Width (in)	N/A	N/A	DWS Contrast?	N/A
			N/A	Landing Slope (%)	N/A	N/A	DWS Length (in)	N/A
			N/A	Landing X Slope (%)	N/A	N/A	DWS Full Width?	N/A
<p>Surveyor Notes:</p> <p>N/A</p> <p>PROW/ADA:</p> <p>Not Found, R304.2.2, R304.5.3</p>			N/A	Landing Curb? (Y/N)	N/A	N/A	DWS Offset (in)	N/A
			N/A	Shared Landing?	N/A			
			N/A	Gutter Ponding?	N/A	N/A	Gutter Slope (%)	N/A
			N/A	Gutter Lip Ht (in)	N/A	N/A	Gutter X Slope (%)	N/A

N/A	Painted X Walk1?	Yes	N/A	Painted X Walk2?	N/A
				X Walk 1 Direction	To NE		X Walk 2 Direction	N/A
			N/A	X Walk 1 Width (in)	110.0	N/A	X Walk 2 Width (in)	N/A
				X Walk 1 Slope (%)	0.1		X Walk 2 Slope (%)	N/A
				X Walk 1 X Slope (%)	0.0		X Walk 2 X Slope (%)	N/A
			N/A	Ramp inside XWalk1?	Yes	N/A	Ramp inside XWalk2?	N/A
			Road Slope (%)	N/A	N/A	Clear Space?	N/A	
			Road X Slope (%)	N/A	N/A	Clear Space to XWalk (in)	N/A	
		N/A	Any Obstructions?	N/A	N/A	Storm Grate/Utility Hazard?	N/A	
			Obstruction Type			Storm Grate/Utility Type		
					N/A		N/A	
					Yes	Surface Condition? (G/P)	Good	
Total Cost:		\$	1650.00
