Access Compliance Report

Public Rights-of-Way

(Curb Ramps)

| Intersection ID: 21685 | Main Street: POPLAR_FOREST_DR | Cross Street: WATERFALL_PL | Location: SW |

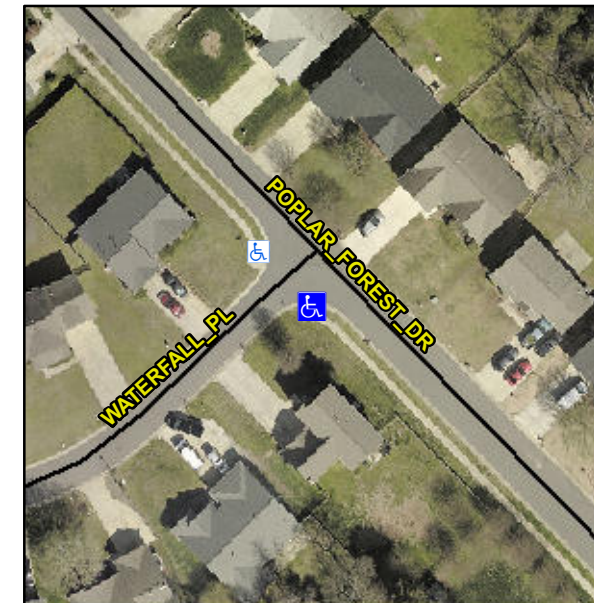
R304.5.1, R304.5.3

| Compliance | Description | Data | Compliance | Description | Data |
|---|---|---|---|---|---|
| N/A | Ramp Length (in) | 96.0 | Yes | Ramp Slope (%) | 6.7 |
| No | Ramp Width (in) | 33.0 | No | Ramp XSlope (%) | 3.7 |

Remove & Replace Curb Ramp With Two New Directional Ramps or Equivalent.
