Access Compliance Report

Public Rights-of-Way

(Curb Ramps)

Intersection ID: 26464	Main Street: BEVINGTON_PL	Cross Street: ENCLAVE_PL	Location: SW
ADA ID: 5A70CDE8831C	Ramp Type: PerpDiag	Initial Pass/Fail: Fail	Overall Compliance: No
Severity Score: 13.75			
Codes/Mitigation Info/Possible Solution		Field Measurements/Component Compliance

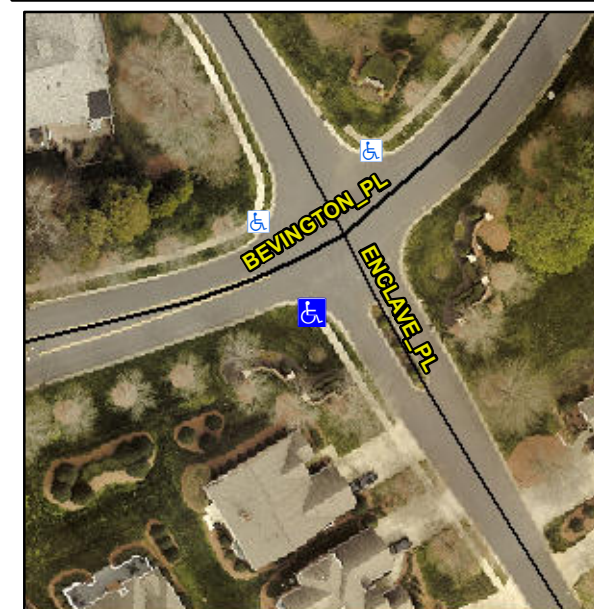
PROW/ADA:

Not Found, R304.2.2, R304.5.3

Compliance	Description	Data	Compliance	Description	Data
N/A	Ramp Length (in)	48.0	No	Ramp Slope (%)	9.7
Yes	Ramp Width (in)	48.0	No	Ramp XSlope (%)	2.6
N/A	Flare Type LT	N/A	N/A	Flare Type RT	N/A
N/A	Flare Slope LT (%)	N/A	N/A	Flare Slope RT (%)	N/A
N/A	Flare Traversable LT?	N/A	N/A	Flare Traversable RT?	N/A
N/A	Landing Length (in)	N/A	N/A	DWS Provided?	N/A
N/A	Landing Width (in)	N/A	N/A	DWS Contrast?	N/A
N/A	Landing Slope (%)	N/A	N/A	DWS Length (in)	N/A
N/A	Landing X Slope (%)	N/A	N/A	DWS Full Width?	N/A
N/A	Landing Curb? (Y/N)	N/A	N/A	DWS Offset (in)	N/A
N/A	Shared Landing?	N/A			
N/A	Gutter Ponding?	N/A	N/A	Gutter Slope (%)	N/A
N/A	Gutter Lip Ht (in)	N/A	N/A	Gutter X Slope (%)	N/A
N/A	Painted X Walk1?	No	N/A	Painted X Walk2?	No
	X Walk 1 Direction	To NE		X Walk 2 Direction	To NW
N/A	X Walk 1 Width (in)	N/A	N/A	X Walk 2 Width (in)	N/A
	X Walk 1 Slope (%)	3.6		X Walk 2 Slope (%)	0.6
	X Walk 1 X Slope (%)	2.1		X Walk 2 X Slope (%)	2.6

N/A	Ramp inside XWalk1?	N/A	N/A	Ramp inside XWalk2?	N/A
	Road Slope (%)	3.3	N/A	Clear Space?	N/A
	Road X Slope (%)	1.2	N/A	Clear Space to XWalk (in)	N/A
N/A	Any Obstructions?	N/A	N/A	Storm Grate/Utility Hazard?	N/A
	Obstruction Type			Storm Grate/Utility Type	
		N/A			N/A
			Yes	Surface Condition? (G/P)	Good

Possible Solutions:

Remove & Replace Curb Ramp With Two New Directional Ramps or Equivalent.
