# Access Compliance Report

## Public Rights-of-Way

Intersection ID: 18149	Main Street: BATHURST_DR	Cross Street: IDLEWILD_RD	Location: SE
ADA ID: 5A74CB0C2AD1	Ramp Type: BlendTrans1	Initial Pass/Fail: Fail	Overall Compliance: No
		Severity Score: 25

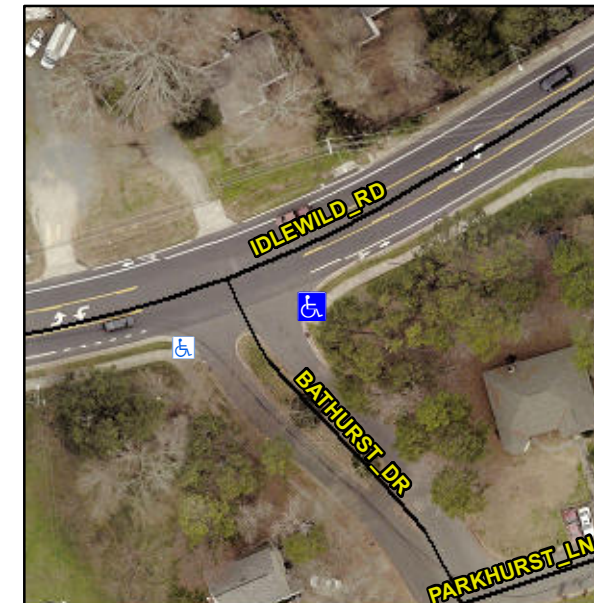
Compliance	Description	Data	Compliance	Description	Data
N/A	Ramp Length (in)	49.0	Yes	BlendTrans Slope (%)	2.0
Yes	Ramp Width (in)	63.0	No	BlendTrans XSlope (%)	9.1
N/A	Flare Type LT	N/A	N/A	Flare Type RT	N/A
N/A	Flare Slope LT (%)	N/A	N/A	Flare Slope RT (%)	N/A
N/A	Flare Traversable LT?	N/A	N/A	Flare Traversable RT?	N/A
N/A	Landing Length (in)	N/A	N/A	DWS Provided?	N/A
N/A	Landing Width (in)	N/A	N/A	DWS Contrast?	N/A
N/A	Landing Slope (%)	N/A	N/A	DWS Length (in)	N/A
N/A	Landing X Slope (%)	N/A	N/A	DWS Full Width?	N/A
N/A	Landing Curb? (Y/N)	N/A	N/A	DWS Offset (in)	N/A
N/A	Shared Landing?	N/A			
N/A	Gutter Ponding?	N/A	N/A	Gutter Slope (%)	N/A
N/A	Gutter Lip Ht (in)	N/A	N/A	Gutter X Slope (%)	N/A
N/A	Painted X Walk1?	No	N/A	Painted X Walk2?	No
	X Walk 1 Direction	To NE		X Walk 2 Direction	To NW
	X Walk 1 Width (in)	N/A		X Walk 2 Width (in)	N/A
	X Walk 1 Slope (%)	9.8		X Walk 2 Slope (%)	0.3
	X Walk 1 X Slope (%)	2.2		X Walk 2 X Slope (%)	9.9

N/A	Ramp inside XWalk1?	N/A	N/A	Ramp inside XWalk2?	N/A
	Road Slope (%)	7.8		Clear Space?	N/A
	Road X Slope (%)	4.7	N/A	Clear Space to XWalk (in)	N/A
N/A	Any Obstructions?	N/A	N/A	Storm Grate/Utility Hazard?	N/A
	Obstruction Type			Storm Grate/Utility Type	
		N/A			N/A
			Yes	Surface Condition? (G/P)	Good
			N/A	Curb Slope (%)	0.7

**Remove & Replace Curb Ramp With Two New Directional Ramps or Equivalent.**
