# Access Compliance Report

## Public Rights-of-Way

### (Curb Ramps)

| Intersection ID: 27679 | Main Street: FOX_HEDGE_RD | Cross Street: HAMPSHIRE_HILL_RD | Location: SE |

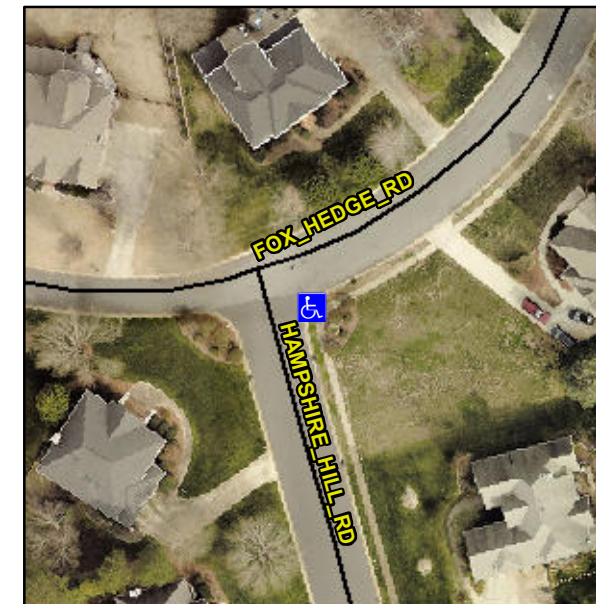
**Not Found, R304.2.2**

| Compliance | Description | Data | Compliance | Description | Data |
|---|---|---|---|---|---|
| N/A | Ramp Length (in) | 48.0 | No | Ramp Slope (%) | 15.4 |

**Remove & Replace Entire Ramp.**
