# Access Compliance Report

## Public Rights-of-Way

### (Curb Ramps)

Intersection ID: 11066	Main Street: BRIARGROVE_DR	Cross Street: MENDHAM_DR	Location: SE
ADA ID: 5A7F6E05DAE7	Ramp Type: BlendTrans1	Initial Pass/Fail: Fail	Overall Compliance: No
		Severity Score: 10

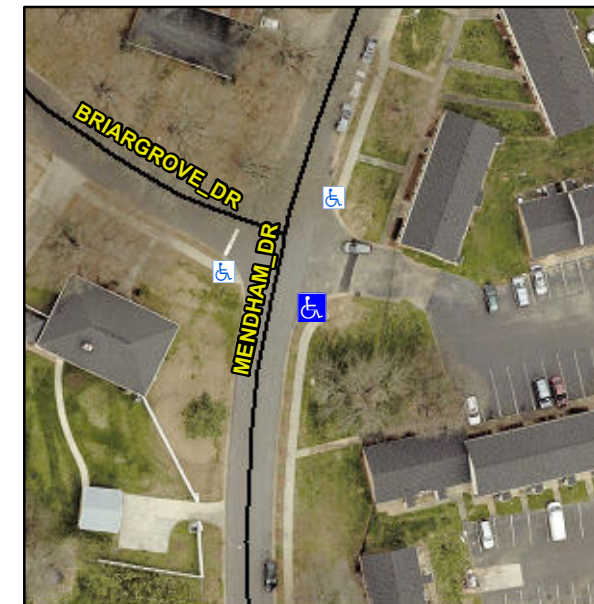
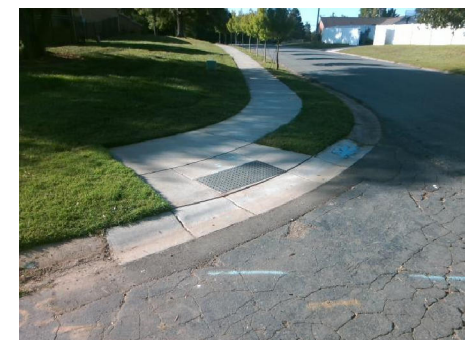
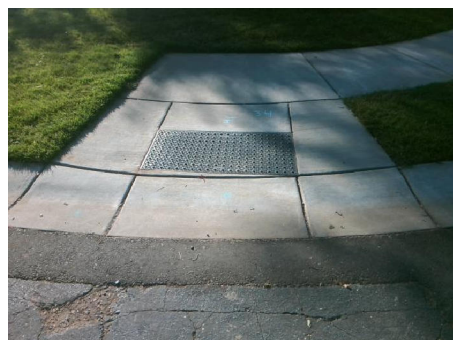
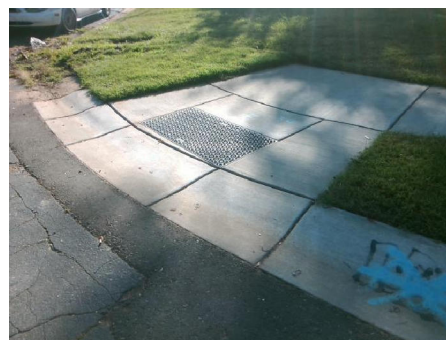
**NO LT SW**

**Not Found, R304.5.1, R304.5.3**

Compliance	Description	Data	Compliance	Description	Data
N/A	Ramp Length (in)	48.0	Yes	BlendTrans Slope (%)	4.1
No	Ramp Width (in)	46.0	No	BlendTrans XSlope (%)	3.4
N/A	Flare Type LT	N/A	N/A	Flare Type RT	N/A
N/A	Flare Slope LT (%)	N/A	N/A	Flare Slope RT (%)	N/A
N/A	Flare Traversable LT?	N/A	N/A	Flare Traversable RT?	N/A
N/A	Landing Length (in)	N/A	N/A	DWS Provided?	N/A
N/A	Landing Width (in)	N/A	N/A	DWS Contrast?	N/A
N/A	Landing Slope (%)	N/A	N/A	DWS Length (in)	N/A
N/A	Landing X Slope (%)	N/A	N/A	DWS Full Width?	N/A
N/A	Landing Curb? (Y/N)	N/A	N/A	DWS Offset (in)	N/A
N/A	Shared Landing?	N/A			
N/A	Gutter Ponding?	N/A	N/A	Gutter Slope (%)	N/A
N/A	Gutter Lip Ht (in)	N/A	N/A	Gutter X Slope (%)	N/A
N/A	Painted X Walk1?	No	N/A	Painted X Walk2?	No
	X Walk 1 Direction	To N		X Walk 2 Direction	To NW
	X Walk 1 Width (in)	N/A		X Walk 2 Width (in)	N/A
	X Walk 1 Slope (%)	0.5		X Walk 2 Slope (%)	2.4
	X Walk 1 X Slope (%)	1.3		X Walk 2 X Slope (%)	2.3

N/A	Ramp inside XWalk1?	N/A	N/A	Ramp inside XWalk2?	N/A
	Road Slope (%)	3.2		Clear Space?	N/A
	Road X Slope (%)	0.5	N/A	Clear Space to XWalk (in)	N/A
N/A	Any Obstructions?	N/A	N/A	Storm Grate/Utility Hazard?	N/A
	Obstruction Type			Storm Grate/Utility Type	
		N/A			N/A
			Yes	Surface Condition? (G/P)	Good
			No	Curb Slope (%)	14.8

**Remove & Replace Curb Ramp With Two New Directional Ramps or Equivalent.**
