Access Compliance Report

Public Rights-of-Way

(Curb Ramps)

Intersection ID: 8199	Main Street: HOVIS_RD	Cross Street: INTERURBAN_AV	Location: NE
ADA ID: 5A847874DF0D	Ramp Type: Directional2	Initial Pass/Fail: Fail	Overall Compliance: No
Severity Score: 33.75			
Codes/Mitigation Info/Possible Solution		Field Measurements/Component Compliance

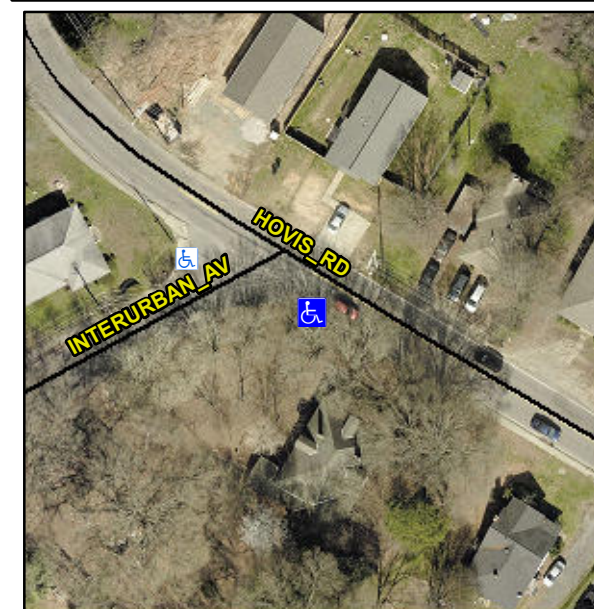
NO CURB

Compliance	Description	Data	Compliance	Description	Data
N/A	Ramp Length (in)	40.0	N/A	Grade Break?	N/A
No	Ramp Width (in)	37.5	N/A	Grade Break Slope (%)	0.0
Yes	Ramp Slope (%)	6.9	N/A	Grade Break XSlope (%)	0.0
No	Ramp XSlope (%)	10.5			
N/A	Flare Type LT	N/A	N/A	Flare Type RT	N/A
N/A	Flare Slope LT (%)	N/A	N/A	Flare Slope RT (%)	0.0
N/A	Flare Traversable LT?	N/A	N/A	Flare Traversable RT?	N/A
N/A	Landing Length (in)	0.0	N/A	DWS Provided?	N/A
N/A	Landing Width (in)	0.0	N/A	DWS Contrast?	N/A
N/A	Landing Slope (%)	0.0	N/A	DWS Length (in)	N/A
N/A	Landing X Slope (%)	0.0	N/A	DWS Full Width?	N/A
N/A	Landing Curb? (Y/N)	N/A	N/A	DWS Offset LT (in)	N/A
N/A	Shared Landing?	N/A	N/A	DWS Offset RT (in)	N/A
N/A	Gutter Ponding?	0.0	N/A	Gutter Slope (%)	N/A
N/A	Gutter Lip Ht (in)	0.0	N/A	Gutter X Slope (%)	N/A
N/A	Painted X Walk1?	No		Road Slope (%)	4.2
	X Walk 1 Direction	To SW		Road X Slope (%)	4.0
	X Walk 1 Width (in)	N/A		Clear Space?	N/A

X Walk 1 Slope (%)	4.2	N/A	Clear Space to XWalk (in)	N/A
	X Walk 1 X Slope (%)	4.0	N/A	Storm Grate/Utility Hazard?	N/A
N/A	Ramp inside XWalk1?	N/A		Storm Grate/Utility Type	
N/A	Any Obstructions?	N/A			N/A
	Obstruction Type		Yes	Surface Condition? (G/P)	Good
			N/A	Curb Slope (%)	N/A

Possible Solutions:

Remove & Replace Entire Ramp.

R304.5.1, R304.5.3
