Access Compliance Report

Public Rights-of-Way

(Curb Ramps)

Intersection ID: 10021845	Main Street: BRIXHAM_HILL_AV	Cross Street: N/A	Location: SW
ADA ID: 5A8661792231	Ramp Type: Perp	Initial Pass/Fail: Fail	Overall Compliance: No
		Severity Score: 22.5

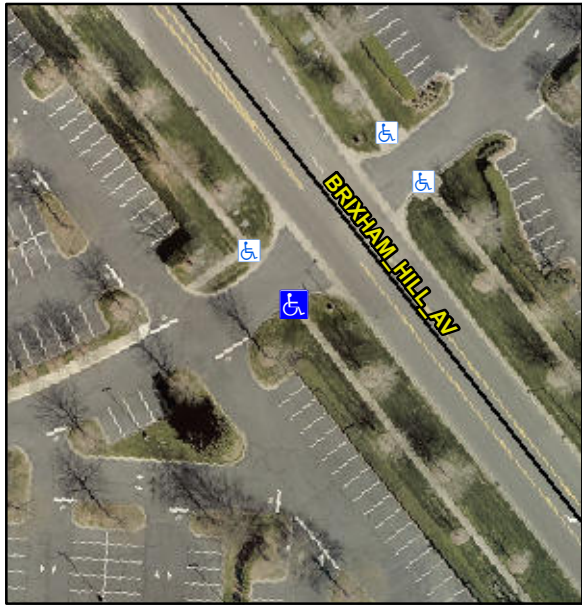
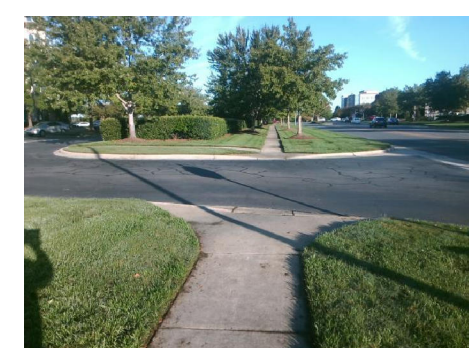
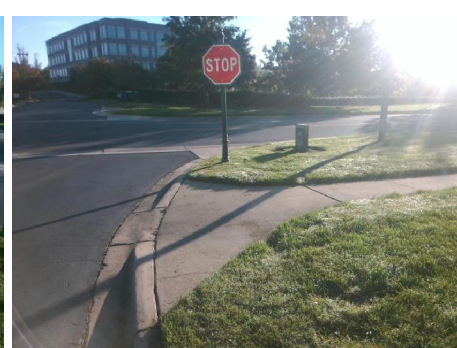
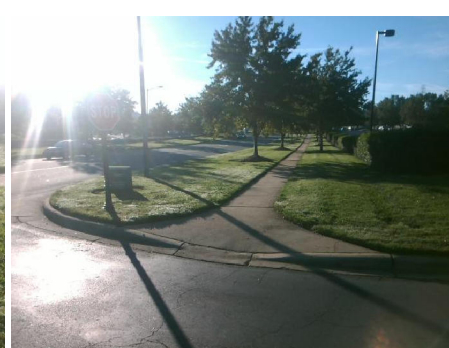
Possible Solutions:		Compliance	Description	Data	Compliance	Description	Data
	Remove & Replace Entire Ramp.		N/A	Ramp Length (in)	94.0	No	Ramp Slope (%)	9.2
			No	Ramp Width (in)	46.5	No	Ramp XSlope (%)	3.4
			N/A	Flare Type LT	N/A	N/A	Flare Type RT	N/A
			N/A	Flare Slope LT (%)	N/A	N/A	Flare Slope RT (%)	N/A
			N/A	Flare Traversable LT?	N/A	N/A	Flare Traversable RT?	N/A
			N/A	Landing Length (in)	N/A	N/A	DWS Provided?	N/A
			N/A	Landing Width (in)	N/A	N/A	DWS Contrast?	N/A
			N/A	Landing Slope (%)	N/A	N/A	DWS Length (in)	N/A
			N/A	Landing X Slope (%)	N/A	N/A	DWS Full Width?	N/A
Surveyor Notes:	N/A		N/A	Landing Curb? (Y/N)	N/A	N/A	DWS Offset (in)	N/A
			N/A	Shared Landing?	N/A			
	PROW/ADA:		N/A	Gutter Ponding?	N/A	N/A	Gutter Slope (%)	N/A
	R304.5.1, R304.2.2, R304.5.3		N/A	Gutter Lip Ht (in)	N/A	N/A	Gutter X Slope (%)	N/A

N/A	Painted X Walk1?	No	N/A	Painted X Walk2?	N/A
				X Walk 1 Direction	To NW		X Walk 2 Direction	N/A
			N/A	X Walk 1 Width (in)	N/A	N/A	X Walk 2 Width (in)	N/A
				X Walk 1 Slope (%)	2.2		X Walk 2 Slope (%)	N/A
				X Walk 1 X Slope (%)	2.7		X Walk 2 X Slope (%)	N/A
			N/A	Ramp inside XWalk1?	N/A	N/A	Ramp inside XWalk2?	N/A
			Road Slope (%)	N/A	N/A	Clear Space?	N/A	
			Road X Slope (%)	N/A	N/A	Clear Space to XWalk (in)	N/A	
		N/A	Any Obstructions?	N/A	N/A	Storm Grate/Utility Hazard?	N/A	
			Obstruction Type			Storm Grate/Utility Type		
					N/A		N/A	
						Yes	Surface Condition? (G/P)	Good
Total Cost:		\$ 1850.00
