# Access Compliance Report

## Public Rights-of-Way

### (Curb Ramps)

Intersection ID: 10142	Main Street: TUCKASEEGEE_RD	Cross Street: TODDVILLE_RD	Location: S
ADA ID: 5A8B7D7331DF	Ramp Type: Perp	Initial Pass/Fail: Fail	Overall Compliance: No
Codes/Mitigation Info/Possible Solution		Field Measurements/Component Compliance	
Severity Score: 13.75

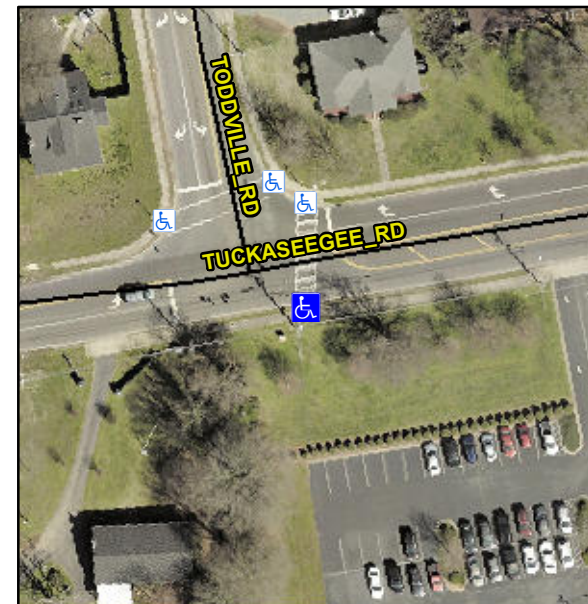
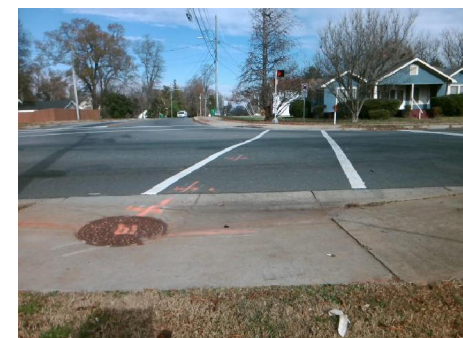
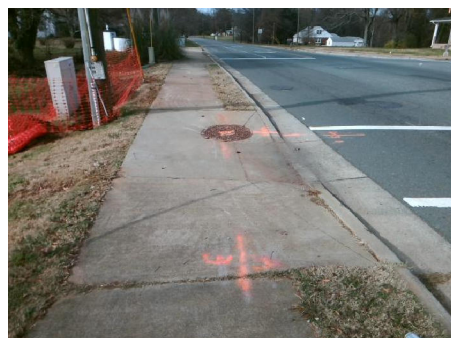
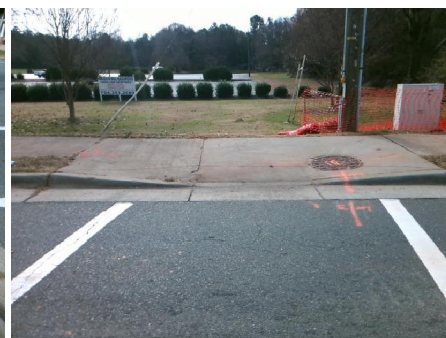
Compliance	Description	Data	Compliance	Description	Data
N/A	Ramp Length (in)	85.0	No	Ramp Slope (%)	9.8
Yes	Ramp Width (in)	62.0	No	Ramp XSlope (%)	2.7
N/A	Flare Type LT	N/A	N/A	Flare Type RT	N/A
N/A	Flare Slope LT (%)	N/A	N/A	Flare Slope RT (%)	N/A
N/A	Flare Traversable LT?	N/A	N/A	Flare Traversable RT?	N/A
N/A	Landing Length (in)	N/A	N/A	DWS Provided?	N/A
N/A	Landing Width (in)	N/A	N/A	DWS Contrast?	N/A
N/A	Landing Slope (%)	N/A	N/A	DWS Length (in)	N/A
N/A	Landing X Slope (%)	N/A	N/A	DWS Full Width?	N/A
N/A	Landing Curb? (Y/N)	N/A	N/A	DWS Offset (in)	N/A
N/A	Shared Landing?	N/A			
N/A	Gutter Ponding?	N/A	N/A	Gutter Slope (%)	N/A
N/A	Gutter Lip Ht (in)	N/A	N/A	Gutter X Slope (%)	N/A
N/A	Painted X Walk1?	Yes	N/A	Painted X Walk2?	N/A
	X Walk 1 Direction	To N		X Walk 2 Direction	N/A
N/A	X Walk 1 Width (in)	109.0	N/A	X Walk 2 Width (in)	N/A
	X Walk 1 Slope (%)	4.6		X Walk 2 Slope (%)	N/A
	X Walk 1 X Slope (%)	0.4		X Walk 2 X Slope (%)	N/A

N/A	Ramp inside XWalk1?	Yes	N/A	Ramp inside XWalk2?	N/A
	Road Slope (%)	N/A	N/A	Clear Space?	N/A
	Road X Slope (%)	N/A	N/A	Clear Space to XWalk (in)	N/A
N/A	Any Obstructions?	N/A	N/A	Storm Grate/Utility Hazard?	N/A
	Obstruction Type			Storm Grate/Utility Type	
		N/A			N/A
		Yes		Surface Condition? (G/P)	Good

Possible Solutions:

**Remove & Replace Entire Ramp.**

**R304.2.2, R304.5.3**

Total Cost:

**\$ 1850.00**
