Access Compliance Report

Public Rights-of-Way

(Curb Ramps)

| Intersection ID: 5249 | Main Street: CAMERON_SPRING_RD | Cross Street: DANNYN_GROVE_CT | Location: SE |

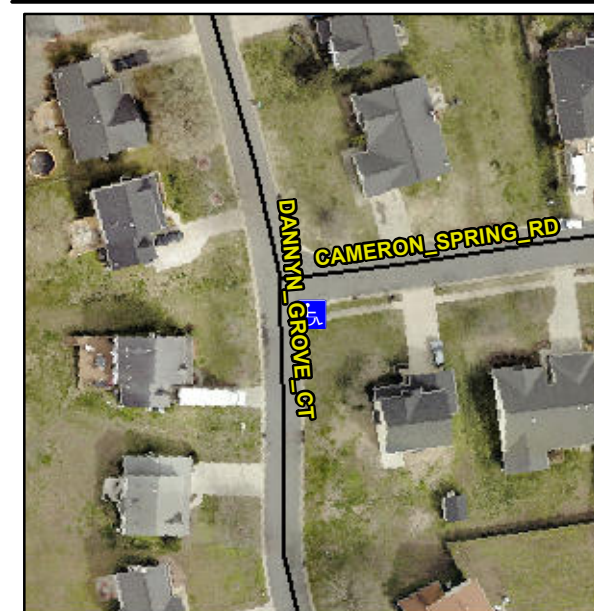
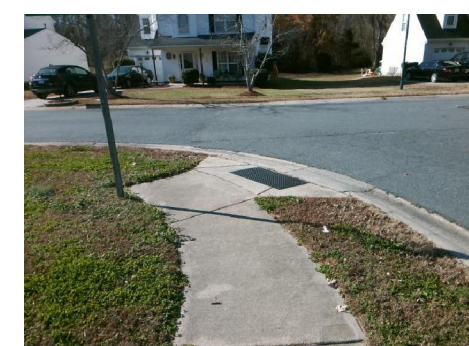
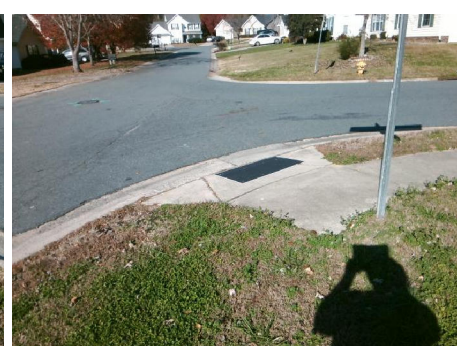
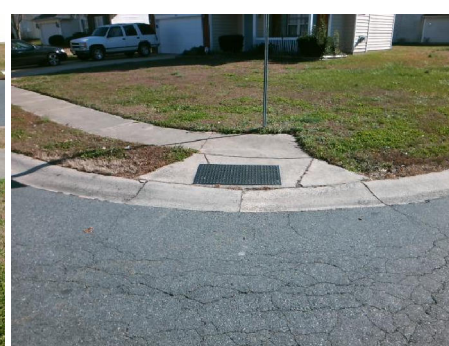
| ADA ID: 5AA7E3AC3D7D | Ramp Type: Perp | Initial Pass/Fail: Fail | Overall Compliance: No |
| Severity Score: 12.5 | | | |

Not Found, R304.2.2

| Compliance | Description | Data | Compliance | Description | Data |
|---|---|---|---|---|---|
| N/A | Ramp Length (in) | 38.0 | No | Ramp Slope (%) | 9.3 |
| Yes | Ramp Width (in) | 64.0 | Yes | Ramp XSlope (%) | 1.9 |

Possible Solutions:

Remove & Replace Entire Ramp.
