Access Compliance Report

Public Rights-of-Way

(Curb Ramps)

Intersection ID: 13767	Main Street: E_5TH_ST	Cross Street: PARK_DR	Location:	N
ADA ID: 5AA94DC451DA	Ramp Type: Perp	Initial Pass/Fail: Fail	Overall Compliance: No	Severity Score: 12.5
Codes/Mitigation Info/Possible Solution		Field Measurements/Component Compliance

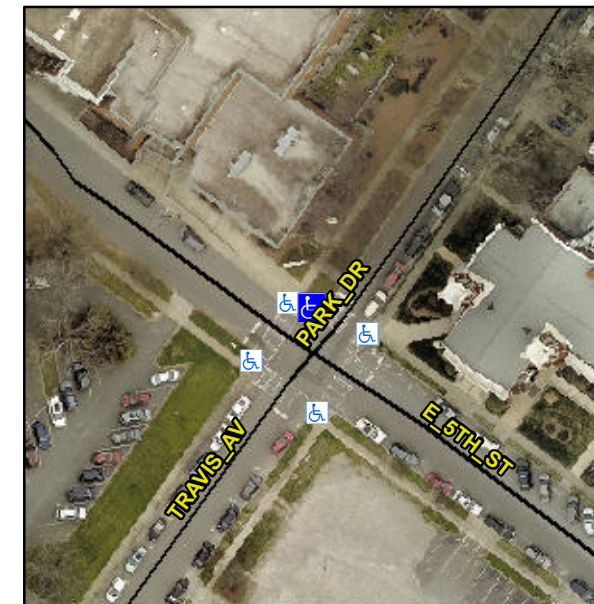
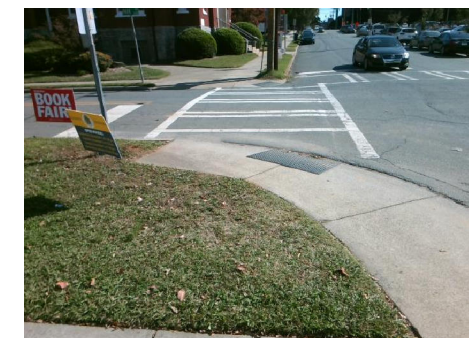
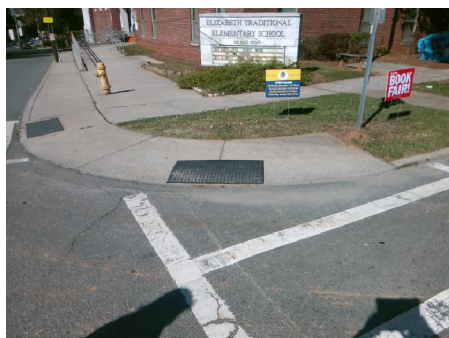
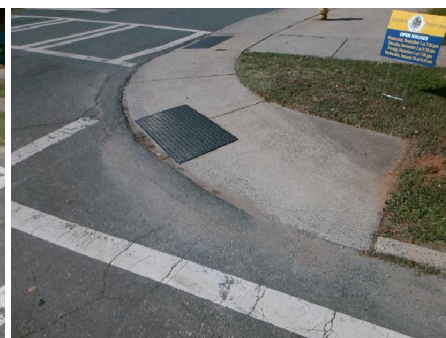
Not Found, R304.2.2

Compliance	Description	Data	Compliance	Description	Data
N/A	Ramp Length (in)	60.0	No	Ramp Slope (%)	10.0
Yes	Ramp Width (in)	120.0	Yes	Ramp XSlope (%)	1.1
N/A	Flare Type LT	N/A	N/A	Flare Type RT	N/A
N/A	Flare Slope LT (%)	N/A	N/A	Flare Slope RT (%)	N/A
N/A	Flare Traversable LT?	N/A	N/A	Flare Traversable RT?	N/A
N/A	Landing Length (in)	N/A	N/A	DWS Provided?	N/A
N/A	Landing Width (in)	N/A	N/A	DWS Contrast?	N/A
N/A	Landing Slope (%)	N/A	N/A	DWS Length (in)	N/A
N/A	Landing X Slope (%)	N/A	N/A	DWS Full Width?	N/A
N/A	Landing Curb? (Y/N)	N/A	N/A	DWS Offset (in)	N/A
N/A	Shared Landing?	N/A			
N/A	Gutter Ponding?	N/A	N/A	Gutter Slope (%)	N/A
N/A	Gutter Lip Ht (in)	1.0	N/A	Gutter X Slope (%)	N/A
N/A	Painted X Walk1?	Yes	N/A	Painted X Walk2?	N/A
	X Walk 1 Direction	To SE		X Walk 2 Direction	N/A
N/A	X Walk 1 Width (in)	114.0	N/A	X Walk 2 Width (in)	N/A
	X Walk 1 Slope (%)	3.2		X Walk 2 Slope (%)	N/A
	X Walk 1 X Slope (%)	1.6		X Walk 2 X Slope (%)	N/A

N/A	Ramp inside XWalk1?	Yes	N/A	Ramp inside XWalk2?	N/A
	Road Slope (%)	N/A	N/A	Clear Space?	N/A
	Road X Slope (%)	N/A	N/A	Clear Space to XWalk (in)	N/A
N/A	Any Obstructions?	N/A	N/A	Storm Grate/Utility Hazard?	N/A
	Obstruction Type			Storm Grate/Utility Type	
		N/A			N/A
			Yes	Surface Condition? (G/P)	Good

Remove & Replace Entire Ramp.
