# Access Compliance Report

## Public Rights-of-Way

### (Curb Ramps)

Intersection ID: 10020375	Main Street: BALLANTYNE CORPORATE PL	Cross Street: N/A	Location: E
ADA ID: 5AA9CEEAD199	Ramp Type: BlendTrans2	Initial Pass/Fail: Fail	Overall Compliance: No
Severity Score: 12.5			
Codes/Mitigation Info/Possible Solution		Field Measurements/Component Compliance

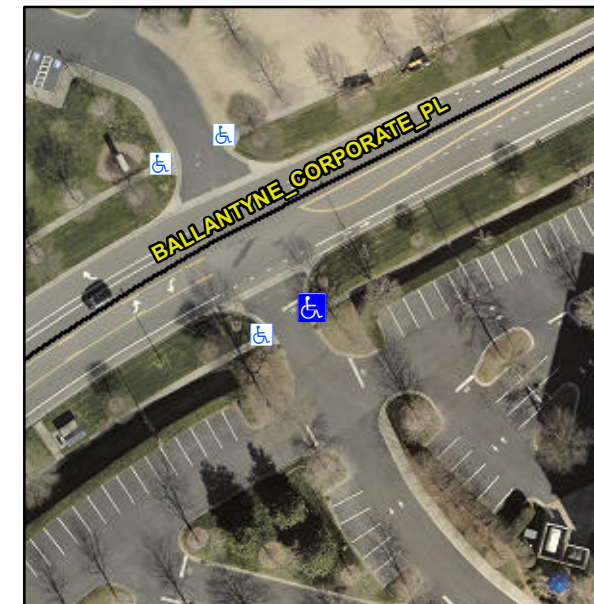
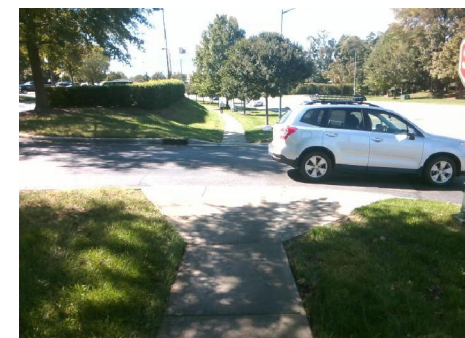
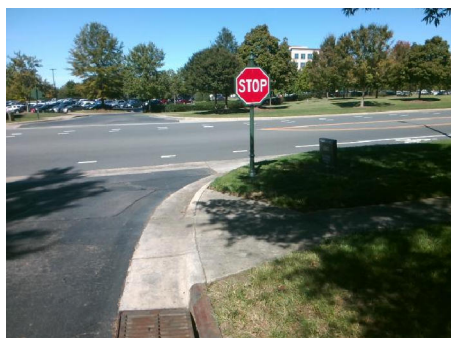
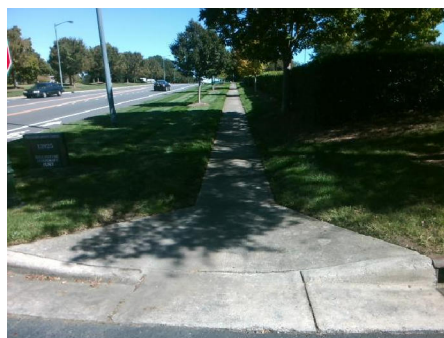
Compliance	Description	Data	Compliance	Description	Data
N/A	Ramp Length (in)	77.0	Yes	BlendTrans Slope (%)	0.3
Yes	Ramp Width (in)	48.0	No	BlendTrans XSlope (%)	6.1
N/A	Flare Type LT	N/A	N/A	Flare Type RT	N/A
N/A	Flare Slope LT (%)	N/A	N/A	Flare Slope RT (%)	N/A
N/A	Flare Traversable LT?	N/A	N/A	Flare Traversable RT?	N/A
N/A	Landing Length (in)	N/A	N/A	DWS Provided?	N/A
N/A	Landing Width (in)	N/A	N/A	DWS Contrast?	N/A
N/A	Landing Slope (%)	N/A	N/A	DWS Length (in)	N/A
N/A	Landing X Slope (%)	N/A	N/A	DWS Full Width?	N/A
N/A	Landing Curb? (Y/N)	N/A	N/A	DWS Offset (in)	N/A
N/A	Shared Landing?	N/A			
N/A	Gutter Ponding?	N/A	N/A	Gutter Slope (%)	N/A
N/A	Gutter Lip Ht (in)	N/A	N/A	Gutter X Slope (%)	N/A
N/A	Painted X Walk1?	No	N/A	Painted X Walk2?	N/A
	X Walk 1 Direction	To SW		X Walk 2 Direction	N/A
	X Walk 1 Width (in)	N/A		X Walk 2 Width (in)	N/A
	X Walk 1 Slope (%)	4.4		X Walk 2 Slope (%)	N/A
	X Walk 1 X Slope (%)	3.1		X Walk 2 X Slope (%)	N/A

N/A	Ramp inside XWalk1?	N/A	N/A	Ramp inside XWalk2?	N/A
	Road Slope (%)	3.1		Clear Space?	N/A
	Road X Slope (%)	4.4	N/A	Clear Space to XWalk (in)	N/A
N/A	Any Obstructions?	N/A	N/A	Storm Grate/Utility Hazard?	N/A
	Obstruction Type			Storm Grate/Utility Type	
		N/A			N/A
			Yes	Surface Condition? (G/P)	Good
			N/A	Curb Slope (%)	3.8

**Remove & Replace Curb Ramp With Two New Directional Ramps or Equivalent.**

**R304.5.3**

**\$ 3200.00**
