Access Compliance Report

Public Rights-of-Way

(Curb Ramps)

Intersection ID: 2639	Main Street: GRAHAMSON_LN	Cross Street: HARTFIELD_DOWNS_DR	Location: S
ADA ID: 5AB0B51298F5	Ramp Type: Perp	Initial Pass/Fail: Fail	Overall Compliance: No
		Severity Score: 1.25

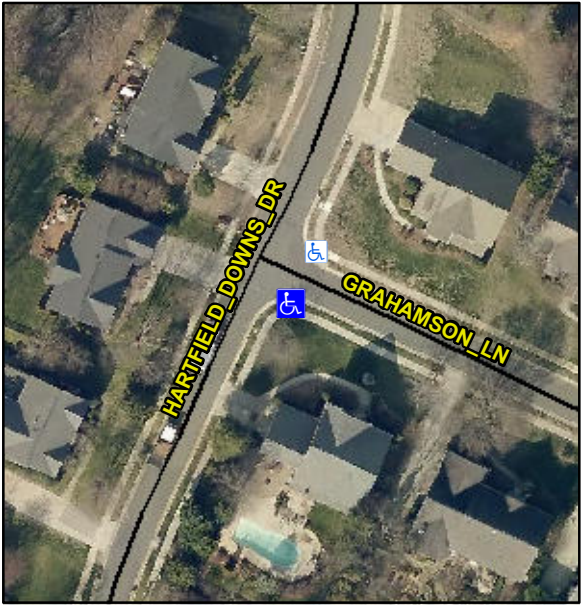
Possible Solutions:		Compliance	Description	Data
	Remove & Replace Entire Ramp.		Yes	Ramp Length (in)	48.0
			No	Ramp Width (in)	100.0
			N/A	Flare Type LT	N/A
			N/A	Flare Slope LT (%)	N/A
			N/A	Flare Traversable LT?	N/A
			N/A	Landing Length (in)	N/A
			N/A	Landing Width (in)	N/A
			N/A	Landing Slope (%)	N/A
			N/A	Landing X Slope (%)	N/A
<p>Surveyor Notes:</p> <p>N/A</p> <p>PROW/ADA:</p> <p>R304.5.3</p>			N/A	Flare Type RT	N/A
			N/A	Flare Slope RT (%)	N/A
			N/A	Flare Traversable RT?	N/A
			N/A	DWS Provided?	N/A
			N/A	DWS Contrast?	N/A
			N/A	DWS Length (in)	N/A
			N/A	DWS Full Width?	N/A
			N/A	DWS Offset (in)	N/A
			N/A	Gutter Ponding?	N/A
			N/A	Gutter Lip Ht (in)	N/A
			No	Painted X Walk1?	N/A
			To NE	X Walk 1 Direction	N/A
			N/A	X Walk 1 Width (in)	N/A

2.8	X Walk 1 Slope (%)	N/A
			2.8	X Walk 1 X Slope (%)	N/A
			N/A	Ramp inside XWalk1?	N/A
			N/A	Road Slope (%)	N/A
			N/A	Road X Slope (%)	N/A
			N/A	Any Obstructions?	N/A
				Obstruction Type	N/A
Total Cost:		\$ 1850.00	N/A	Clear Space?	N/A
			N/A	Clear Space to XWalk (in)	N/A
			N/A	Storm Grate/Utility Hazard?	N/A
				Storm Grate/Utility Type	N/A
			Yes	Surface Condition? (G/P)	Good
