Access Compliance Report

Public Rights-of-Way

Intersection ID: 46914	Main Street: PONDEROSA_PINE_LN	Cross Street: HARRISBURG_RD	Location: NW
ADA ID: 5AB45D4DC90F	Ramp Type: BlendTrans1	Initial Pass/Fail: Fail	Overall Compliance: No
Severity Score: 21.25			
Codes/Mitigation Info/Possible Solution		Field Measurements/Component Compliance

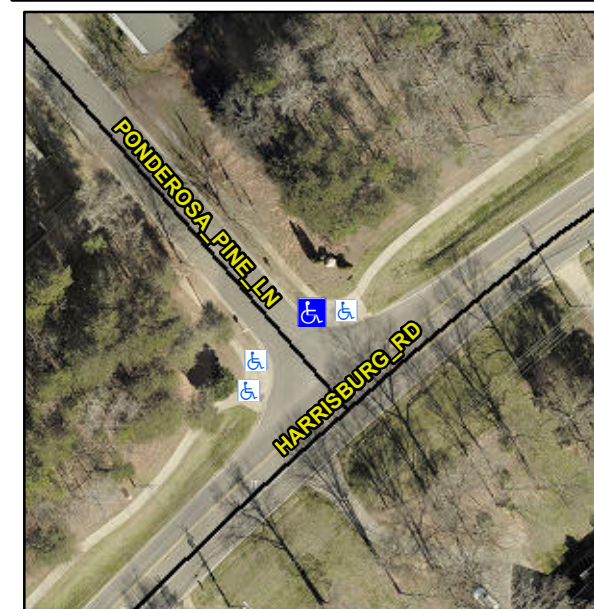
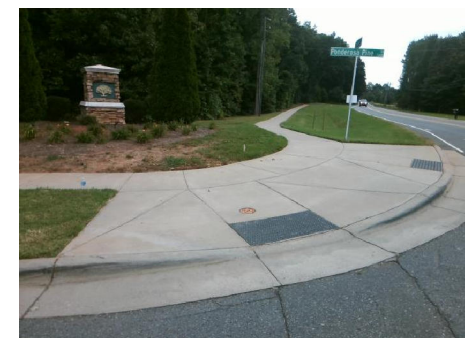
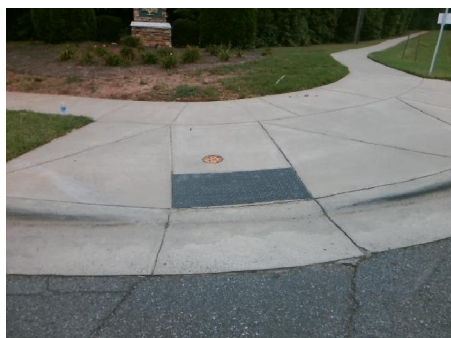
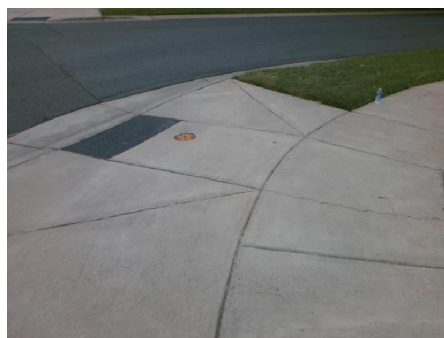
Not Found, R304.5.1, R304.5.3

Compliance	Description	Data	Compliance	Description	Data
N/A	Ramp Length (in)	84.5	Yes	BlendTrans Slope (%)	2.2
No	Ramp Width (in)	47.5	No	BlendTrans XSlope (%)	6.5
N/A	Flare Type LT	N/A	N/A	Flare Type RT	N/A
N/A	Flare Slope LT (%)	N/A	N/A	Flare Slope RT (%)	N/A
N/A	Flare Traversable LT?	N/A	N/A	Flare Traversable RT?	N/A
N/A	Landing Length (in)	N/A	N/A	DWS Provided?	N/A
N/A	Landing Width (in)	N/A	N/A	DWS Contrast?	N/A
N/A	Landing Slope (%)	N/A	N/A	DWS Length (in)	N/A
N/A	Landing X Slope (%)	N/A	N/A	DWS Full Width?	N/A
N/A	Landing Curb? (Y/N)	N/A	N/A	DWS Offset (in)	N/A
N/A	Shared Landing?	N/A			
N/A	Gutter Ponding?	N/A	N/A	Gutter Slope (%)	N/A
N/A	Gutter Lip Ht (in)	N/A	N/A	Gutter X Slope (%)	N/A
N/A	Painted X Walk1?	No	N/A	Painted X Walk2?	N/A
	X Walk 1 Direction	To SW		X Walk 2 Direction	N/A
	X Walk 1 Width (in)	N/A		X Walk 2 Width (in)	N/A
	X Walk 1 Slope (%)	5.4		X Walk 2 Slope (%)	N/A
	X Walk 1 X Slope (%)	5.2		X Walk 2 X Slope (%)	N/A

N/A	Ramp inside XWalk1?	N/A	N/A	Ramp inside XWalk2?	N/A
	Road Slope (%)	5.2		Clear Space?	N/A
	Road X Slope (%)	5.4	N/A	Clear Space to XWalk (in)	N/A
N/A	Any Obstructions?	N/A	N/A	Storm Grate/Utility Hazard?	N/A
	Obstruction Type			Storm Grate/Utility Type	
		N/A			N/A
			Yes	Surface Condition? (G/P)	Good
			No	Curb Slope (%)	18.6

Remove & Replace Curb Ramp With Two New Directional Ramps or Equivalent.
