Access Compliance Report

Public Rights-of-Way

(Curb Ramps)

Intersection ID: 24451	Main Street: CARMEL_RD	Cross Street: WATERFORD_DR	Location: NE
ADA ID: 5ABD240BE6D3	Ramp Type: PerpDiag	Initial Pass/Fail: Fail	Overall Compliance: No
Severity Score: 22.5			
Codes/Mitigation Info/Possible Solution		Field Measurements/Component Compliance

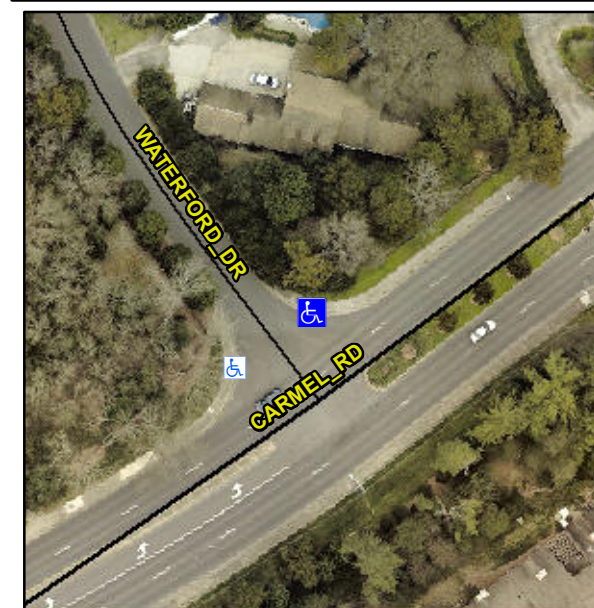
Not Found, R304.5.1, R304.2.2, R304.5.3

Compliance	Description	Data	Compliance	Description	Data
N/A	Ramp Length (in)	56.0	No	Ramp Slope (%)	11.7
No	Ramp Width (in)	43.0	No	Ramp XSlope (%)	2.3
N/A	Flare Type LT	N/A	N/A	Flare Type RT	N/A
N/A	Flare Slope LT (%)	N/A	N/A	Flare Slope RT (%)	N/A
N/A	Flare Traversable LT?	N/A	N/A	Flare Traversable RT?	N/A
N/A	Landing Length (in)	N/A	N/A	DWS Provided?	N/A
N/A	Landing Width (in)	N/A	N/A	DWS Contrast?	N/A
N/A	Landing Slope (%)	N/A	N/A	DWS Length (in)	N/A
N/A	Landing X Slope (%)	N/A	N/A	DWS Full Width?	N/A
N/A	Landing Curb? (Y/N)	N/A	N/A	DWS Offset (in)	N/A
N/A	Shared Landing?	N/A			
N/A	Gutter Ponding?	N/A	N/A	Gutter Slope (%)	N/A
N/A	Gutter Lip Ht (in)	N/A	N/A	Gutter X Slope (%)	N/A
N/A	Painted X Walk1?	No	N/A	Painted X Walk2?	No
	X Walk 1 Direction	To SW		X Walk 2 Direction	To S
N/A	X Walk 1 Width (in)	N/A	N/A	X Walk 2 Width (in)	N/A
	X Walk 1 Slope (%)	3.9		X Walk 2 Slope (%)	1.9
	X Walk 1 X Slope (%)	3.2		X Walk 2 X Slope (%)	1.2

N/A	Ramp inside XWalk1?	N/A	N/A	Ramp inside XWalk2?	N/A
	Road Slope (%)	1.7	N/A	Clear Space?	N/A
	Road X Slope (%)	4.4	N/A	Clear Space to XWalk (in)	N/A
N/A	Any Obstructions?	N/A	N/A	Storm Grate/Utility Hazard?	N/A
	Obstruction Type			Storm Grate/Utility Type	
		N/A			N/A
			Yes	Surface Condition? (G/P)	Good

Possible Solutions:

Remove & Replace Curb Ramp With Two New Directional Ramps or Equivalent.
