# Access Compliance Report

## Public Rights-of-Way (Curb Ramps)

Intersection ID: 31190	Main Street: CROFT_HAVEN_DR	Cross Street: DAVIS_RIDGE_DR	Location: NE
ADA ID: 5ACD35BC6CAC	Ramp Type: PerpDiag	Initial Pass/Fail: Fail	Overall Compliance: No
Severity Score: 25			
Codes/Mitigation Info/Possible Solution		Field Measurements/Component Compliance

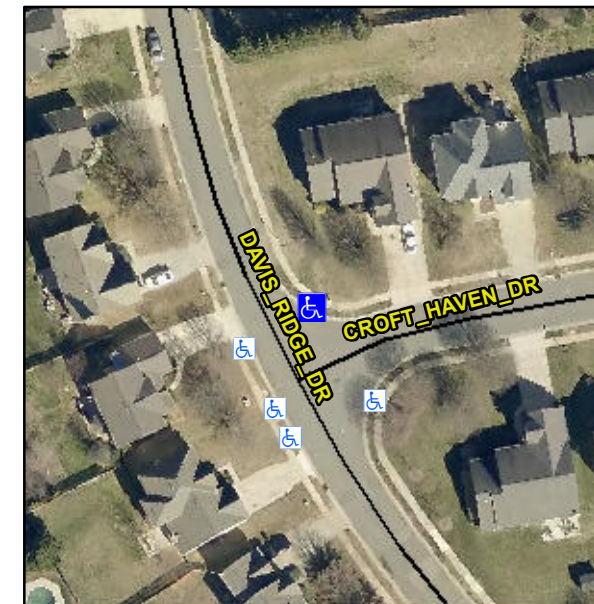
**Not Found, R304.5.3**

Compliance	Description	Data	Compliance	Description	Data
N/A	Ramp Length (in)	48.0	Yes	Ramp Slope (%)	8.3
Yes	Ramp Width (in)	48.0	No	Ramp XSlope (%)	7.3
N/A	Flare Type LT	N/A	N/A	Flare Type RT	N/A
N/A	Flare Slope LT (%)	N/A	N/A	Flare Slope RT (%)	N/A
N/A	Flare Traversable LT?	N/A	N/A	Flare Traversable RT?	N/A
N/A	Landing Length (in)	N/A	N/A	DWS Provided?	N/A
N/A	Landing Width (in)	N/A	N/A	DWS Contrast?	N/A
N/A	Landing Slope (%)	N/A	N/A	DWS Length (in)	N/A
N/A	Landing X Slope (%)	N/A	N/A	DWS Full Width?	N/A
N/A	Landing Curb? (Y/N)	N/A	N/A	DWS Offset (in)	N/A
N/A	Shared Landing?	N/A			
N/A	Gutter Ponding?	N/A	N/A	Gutter Slope (%)	N/A
N/A	Gutter Lip Ht (in)	N/A	N/A	Gutter X Slope (%)	N/A
N/A	Painted X Walk1?	No	N/A	Painted X Walk2?	No
	X Walk 1 Direction	To W		X Walk 2 Direction	To S
N/A	X Walk 1 Width (in)	N/A	N/A	X Walk 2 Width (in)	N/A
	X Walk 1 Slope (%)	5.6		X Walk 2 Slope (%)	5.9
	X Walk 1 X Slope (%)	6.4		X Walk 2 X Slope (%)	4.7

N/A	Ramp inside XWalk1?	N/A	N/A	Ramp inside XWalk2?	N/A
	Road Slope (%)	5.9	N/A	Clear Space?	N/A
	Road X Slope (%)	0.8	N/A	Clear Space to XWalk (in)	N/A
N/A	Any Obstructions?	N/A	N/A	Storm Grate/Utility Hazard?	N/A
	Obstruction Type			Storm Grate/Utility Type	
		N/A			N/A
			Yes	Surface Condition? (G/P)	Good

**Remove & Replace Curb Ramp With Two New Directional Ramps or Equivalent.**
