# Access Compliance Report

## Public Rights-of-Way

### (Curb Ramps)

Intersection ID: 17009	Main Street: N_WENDOVER_RD	Cross Street: RANDOLPH_RD	Location: SW
ADA ID: 5AD5EC7C0B41	Ramp Type: Perp	Initial Pass/Fail: Fail	Overall Compliance: No
Codes/Mitigation Info/Possible Solution			Severity Score: 10
			Field Measurements/Component Compliance

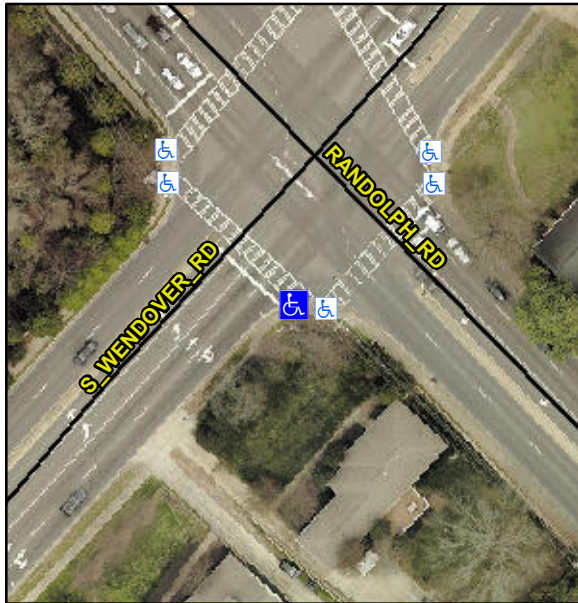
Compliance	Description	Data	Compliance	Description	Data
N/A	Ramp Length (in)	61.0	Yes	Ramp Slope (%)	6.9
No	Ramp Width (in)	42.0	No	Ramp XSlope (%)	3.0
N/A	Flare Type LT	N/A	N/A	Flare Type RT	N/A
N/A	Flare Slope LT (%)	N/A	N/A	Flare Slope RT (%)	N/A
N/A	Flare Traversable LT?	N/A	N/A	Flare Traversable RT?	N/A
N/A	Landing Length (in)	N/A	N/A	DWS Provided?	N/A
N/A	Landing Width (in)	N/A	N/A	DWS Contrast?	N/A
N/A	Landing Slope (%)	N/A	N/A	DWS Length (in)	N/A
N/A	Landing X Slope (%)	N/A	N/A	DWS Full Width?	N/A
N/A	Landing Curb? (Y/N)	N/A	N/A	DWS Offset (in)	N/A
N/A	Shared Landing?	N/A			
N/A	Gutter Ponding?	N/A	N/A	Gutter Slope (%)	N/A
N/A	Gutter Lip Ht (in)	N/A	N/A	Gutter X Slope (%)	N/A
N/A	Painted X Walk1?	Yes	N/A	Painted X Walk2?	N/A
	X Walk 1 Direction	To NW		X Walk 2 Direction	N/A
N/A	X Walk 1 Width (in)	112.0	N/A	X Walk 2 Width (in)	N/A
	X Walk 1 Slope (%)	5.5		X Walk 2 Slope (%)	N/A
	X Walk 1 X Slope (%)	0.9		X Walk 2 X Slope (%)	N/A

N/A	Ramp inside XWalk1?	Yes	N/A	Ramp inside XWalk2?	N/A
	Road Slope (%)	N/A	N/A	Clear Space?	N/A
	Road X Slope (%)	N/A	N/A	Clear Space to XWalk (in)	N/A
N/A	Any Obstructions?	N/A	N/A	Storm Grate/Utility Hazard?	N/A
	Obstruction Type			Storm Grate/Utility Type	
		N/A			N/A
		Yes		Surface Condition? (G/P)	Good

Possible Solutions:

**Remove & Replace Entire Ramp.**

**R304.5.1, R304.5.3**
