# Access Compliance Report

## Public Rights-of-Way

### (Curb Ramps)

Intersection ID: 15178	Main Street: DILWORTH_RD_EAST	Cross Street: IDEAL_WY	Location: SE
ADA ID: 5ADF047535B6	Ramp Type: BlendTrans1	Initial Pass/Fail: Pass	Overall Compliance: No
Severity Score: 22.5			
Codes/Mitigation Info/Possible Solution		Field Measurements/Component Compliance

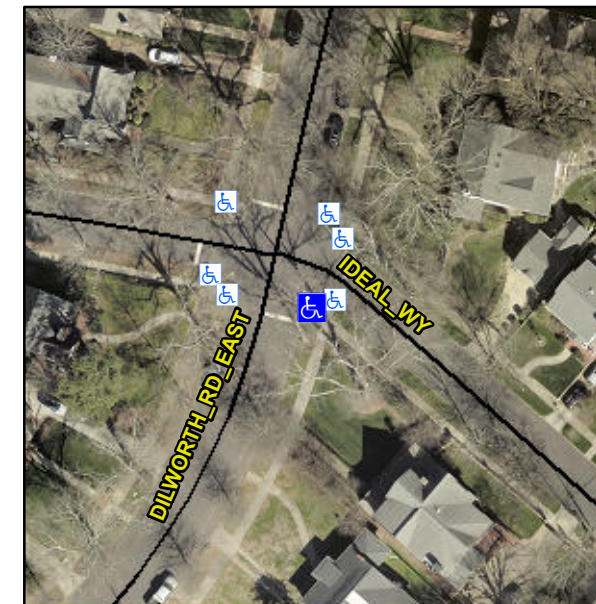
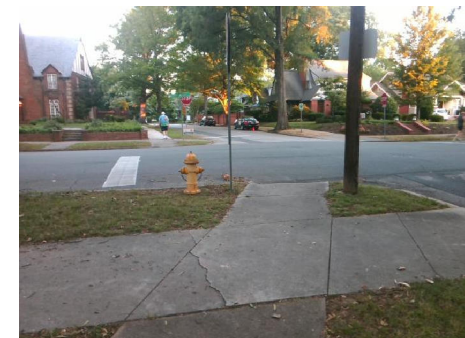
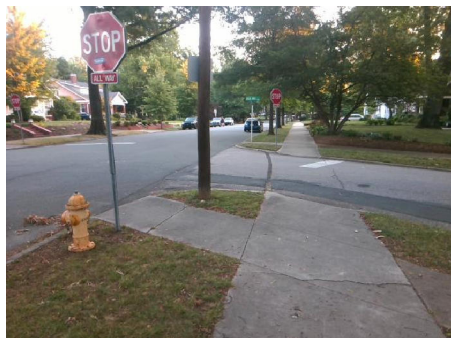
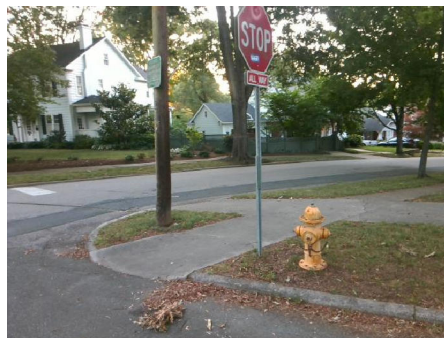
**LNDG NOT SHARED**

**Not Found, R304.2.2-Perp, R304.3.2-Para, R304.5.3, R305, R302.7.2, R304.5.4**

Compliance	Description	Data	Compliance	Description	Data
N/A	Ramp Length (in)	45.0	Yes	BlendTrans Slope (%)	3.9
Yes	Ramp Width (in)	48.0	Yes	BlendTrans XSlope (%)	1.4
N/A	Flare Type LT	Sloped	N/A	Flare Type RT	Sloped
N/A	Flare Slope LT (%)	15.1	N/A	Flare Slope RT (%)	28.2
N/A	Flare Traversable LT?	No	N/A	Flare Traversable RT?	No
Yes	Landing Length (in)	48.0	No	DWS Provided?	No
Yes	Landing Width (in)	60.0	N/A	DWS Contrast?	No
No	Landing Slope (%)	2.6	N/A	DWS Length (in)	N/A
No	Landing X Slope (%)	2.9	N/A	DWS Full Width?	No
N/A	Landing Curb? (Y/N)	No	N/A	DWS Offset (in)	N/A
N/A	Shared Landing?	No			
Yes	Gutter Ponding?	No	No	Gutter Slope (%)	5.7
No	Gutter Lip Ht (in)	0.5	No	Gutter X Slope (%)	2.8
N/A	Painted X Walk1?	No	N/A	Painted X Walk2?	N/A
	X Walk 1 Direction	To W		X Walk 2 Direction	N/A
	X Walk 1 Width (in)	N/A		X Walk 2 Width (in)	N/A
	X Walk 1 Slope (%)	3.7		X Walk 2 Slope (%)	N/A
	X Walk 1 X Slope (%)	0.8		X Walk 2 X Slope (%)	N/A

N/A	Ramp inside XWalk1?	N/A	N/A	Ramp inside XWalk2?	N/A
	Road Slope (%)	0.8		Clear Space?	Yes
	Road X Slope (%)	3.7	N/A	Clear Space to XWalk (in)	N/A
Yes	Any Obstructions?	No	Yes	Storm Grate/Utility Hazard?	No
	Obstruction Type			Storm Grate/Utility Type	
		N/A			N/A
			Yes	Surface Condition? (G/P)	Good
			No	Curb Slope (%)	5.2

**Remove & Replace Curb Ramp With Two New Directional Ramps or Equivalent. Remove & Replace Gutter.**
